Binder Flushing in Low Traffic Volume Superpave Mixes

Magdy A. Abdelrahman¹⁺, Wayne G. Jensen², and Hassan M. Salem³

Abstract: This paper analyzes early flushing or “bleeding” that occurred in several sections of Superpave pavement designed for low traffic volume roads in Nebraska. The objective of this study was to develop a better understanding of the causes of flushing and to examine the relationship between flushing and the material specifications for low traffic volume Superpave mixes. Records indicate that construction of the flushed sections proceeded within specifications. Moreover, all QA/QC material test results were within acceptable ranges. A review of mix design parameters for all flushed sections was conducted to verify compliance with Superpave specifications. Comparison of specified parameters between flushed and non-flushed sections with identical mix designs were also conducted. Field samples from flushed and non-flushed sections were obtained and analyzed for mix design verification and binder characterization. Additional testing on recovered asphalt binders was conducted to assess binder contribution to flushing. Results indicated that recovered binder propert

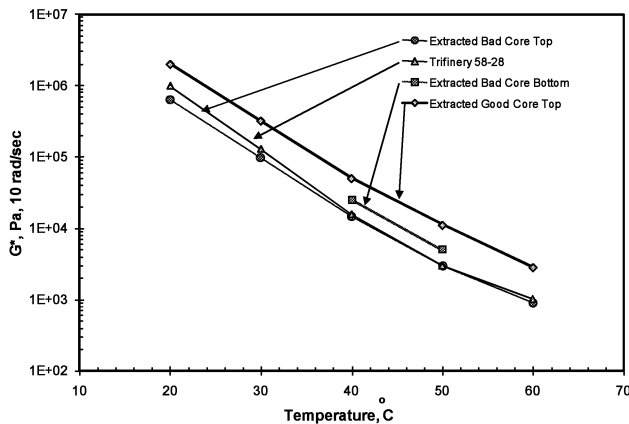
Fig. 2. Comparisons of Extracted Cores and Original Asphalt [7].

During the summer of 2000, an initial study was conducted to determine the cause(s) of flushing on Highway 43. Cores from several pavement sections were obtained and analyzed to determine chemical and physical properties of the binder and to verify design and construction parameters of the flushed mixes [7]. Table 3 and Fig. 2 contain results of testing on the original and extracted binder. The study did not discover any conclusive evidence as to the cause(s) of flushing on Highway 43. The analysis, however, did discover some unusual chemical properties in the extracted binder that were significantly different from those that existed in the original binder. The study found a residual material with lower boiling point in the extracted binder that did not exist in the original binder [7]. Extracted binders were found to be substantially softer than the originals. There were indications that a low compatibility binder had separated, with one of the resulting products consisting of an oily residue which softened the asphalt mix. The original mix design called for 5% asphalt by weight. Flushed cores showed higher asphalt content, with an average value of 6.99% by weight [7]. Non-flushed cores showed an average of 4.92% asphalt content by weight. During this study, it was also discovered that flushing problems with asphalt binders in low traffic volume Superpave asphalt mixes were being experienced in other states.

The chemical analysis on the Highway 43 samples indicated binder-aggregate compatibility problems in the extracted binders. Thermal analysis showed a lower molecular weight material than the original asphalt in the extracted binder. Binder compatibility

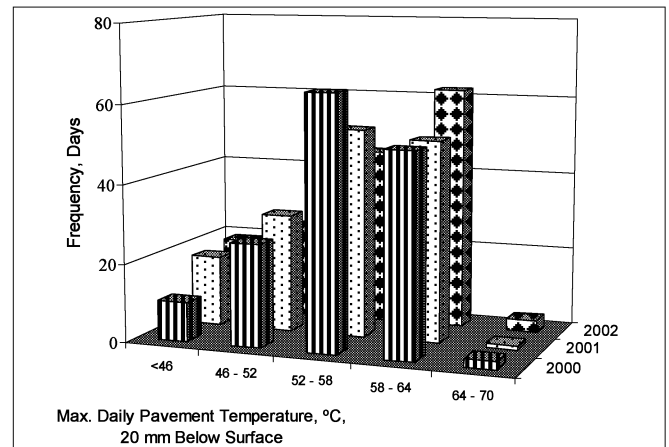
**Fig. 3.** Frequency of Maximum Daily Pavement Temperature, Highway-56.

Fig. 3 presents a frequency (in days) of maximum daily temperature based on the assumption of $d_{(0.50)} = 5.6^{\circ}\text{C}$ for Highway 56. Fig. 3 shows that pavement temperature 20.0mm below surface was higher than 58°C for about sixty days in each of the past three years. The data indicate that a PG 64 binder would be a better choice for the Highway 56 location. Similar conclusions were reached for the other flushed sections. The NDOR stopped using PG 58 grade binders in Superpave mixes after the 2001 construction season. While the maximum pavement temperature was higher than design values for all flushed sections, the temperature at a depth of 10.0cm (4.0inches) was not sufficient to soften the binder to the point where it begins to flow. Testing on extracted core materials confirmed this finding.
