## Binder Flushing in Low Traffic Volume Superpave Mixes

**Abstract:** This paper analyzes early flushing or “bleeding” that occurred in several sections of Superpave pavement designed for low traffic volume roads in Nebraska. The objective of this study was to develop a better understanding of the causes of flushing and to examine the relationship between flushing and the material specifications for low traffic volume Superpave mixes. Records indicate that construction of the flushed sections proceeded within specifications. Moreover, all QA/QC material test results were within acceptable ranges. A review of mix design parameters for all flushed sections was conducted to verify compliance with Superpave specifications. Comparison of specified parameters between flushed and non-flushed sections with identical mix designs were also conducted. Field samples from flushed and non-flushed sections were obtained and analyzed for mix design verification and binder characterization. Additional testing on recovered asphalt binders was conducted to assess binder contribution to flushing. Results indicated that recovered binder properties did not meet Superpave specifications. This research

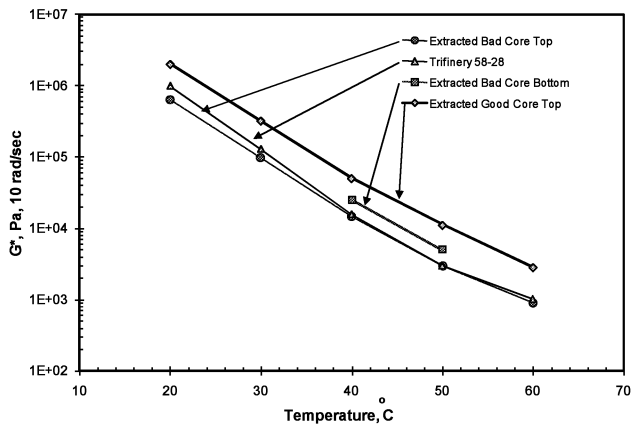
Fig. 2. Comparisons of Extracted Cores and Original Asphalt [7].

Table 4 shows the properties of extracted binders from pavement cores. QA/QC data on original binders is shown in Table 5. Flushed sections had been in service for three to four years when cores were extracted. Original binders were PG 58-28 with testing at 58°C for Rolling Thin Film Oven Test (RTFOT) and at 19°C for Pressure Aging Vessel (PAV). Recovered binders from the pavement cores were expected to be stiffer than RTFOT values but softer than PAV values. Results show extracted binders varied in stiffness, but all were softer than RTFOT values and significantly softer than PAV values. In two cases, extracted binders were softer than the original, un-aged binder. Similar results were obtained from the Highway 43 initial flushing study [7].

The chemical analysis on the Highway 43 samples indicated binder-aggregate compatibility problems in the extracted binders. Thermal analysis showed a lower molecular weight material than the original asphalt in the extracted binder. Binder compatibility

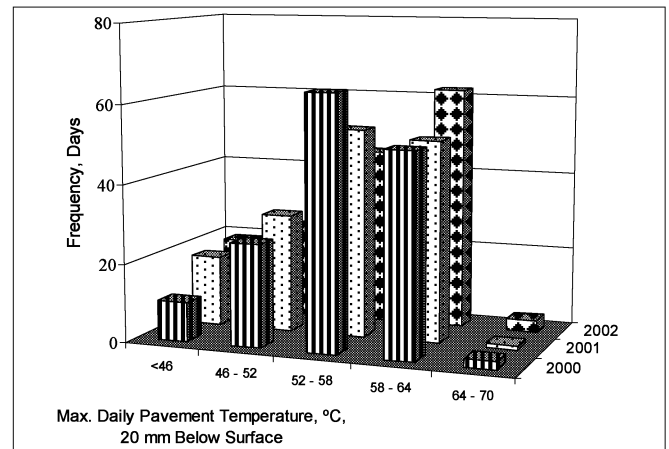
**Fig. 3.** Frequency of Maximum Daily Pavement Temperature, Highway-56.

Fig. 3 presents a frequency (in days) of maximum daily temperature based on the assumption of  $d_{(0.50)} = 5.6^{\circ}\text{C}$  for Highway 56. Fig. 3 shows that pavement temperature 20.0mm below surface was higher than 58°C for about sixty days in each of the past three years. The data indicate that a PG 64 binder would be a better choice for the Highway 56 location. Similar conclusions were reached for the other flushed sections. The NDOR stopped using PG 58 grade binders in Superpave mixes after the 2001 construction season. While the maximum pavement temperature was higher than design values for all flushed sections, the temperature at a depth of 10.0cm (4.0inches) was not sufficient to soften the binder to the point where it begins to flow. Testing on extracted core materials confirmed this finding.

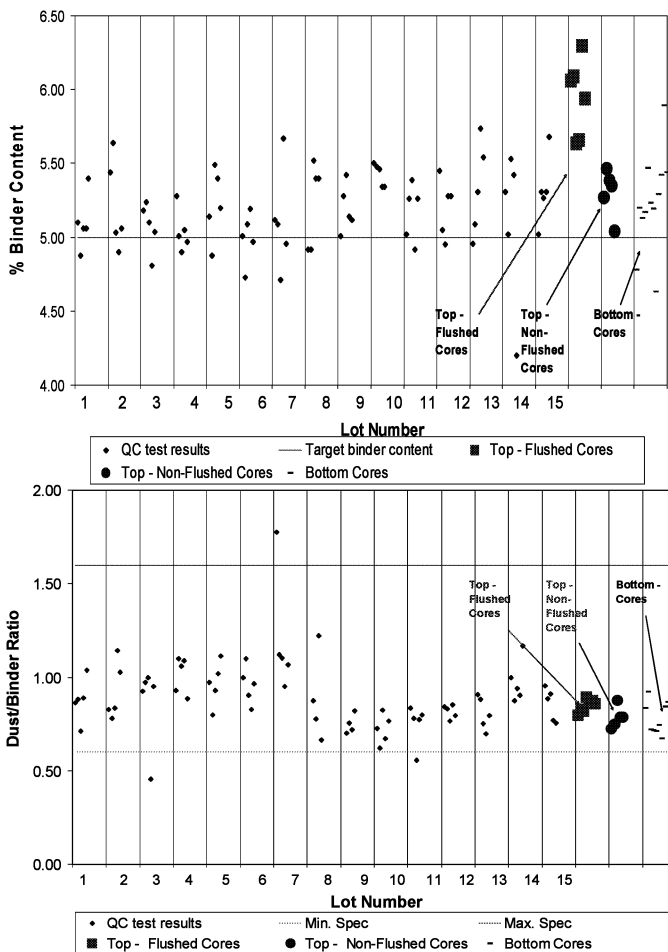
**Fig. 4.** Comparisons of QA/QC Data with Field Cores for Highway-56.

the temperature within pavement sections that did not flush. Temperature is seldom the cause of flushing unless other factors contribute to the problem. From binder testing on extracted cores, mix parameters were shown to vary from both QA/QC records and mix design. As shown in Fig. 4, for Highway 56 significant variability existed within both D/B ratio and binder content.

Recovered cores averaged almost 2.0% higher than design binder content and in many cases were significantly softer than the original binder. Softer binders often produce separation problems. However, QA/QC testing for binder separation is not commonly required by the NDOR for asphalt construction projects. Performance graded binders are normally purchased from suppliers with a maximum level of separation certified by the manufacturer.

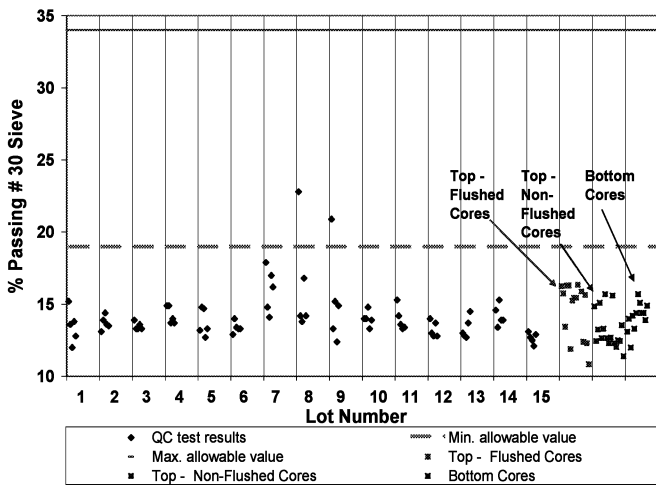
Fig. 5. Highway 56 - Percentage Passing # 30 Sieve versus Lot Number.

Fig. 5 illustrates the low content of material passing the #30 sieve versus the lot number for Highway 56. This figure confirms that poor QA/QC procedures and the relaxed nature of low volume road specifications in effect at the time significantly contributed to the flushing problem. Finer materials have higher surface area than coarser materials and adhere to free asphalt particles in the matrix. Lack of significant percentages of fine materials provide more free asphalt, thereby increasing the potential for binder flushing.

part of the QA process for low traffic volume Superpave mixes is needed to ensure more consistency during the construction process. That need was demonstrated by the variability of material properties within extracted binders and by the differences in measured parameters between the extracted cores, the mix design, and the values recorded by QA/QC personnel during construction. This paper confirms that early flushing is related to QA/QC problems on low volume roads rather than being a Superpave specification issue. Effort is needed to enhance the specifications for low volume Superpave mixes by including binder separation in QA/QC, sampling and mix acceptance procedures.

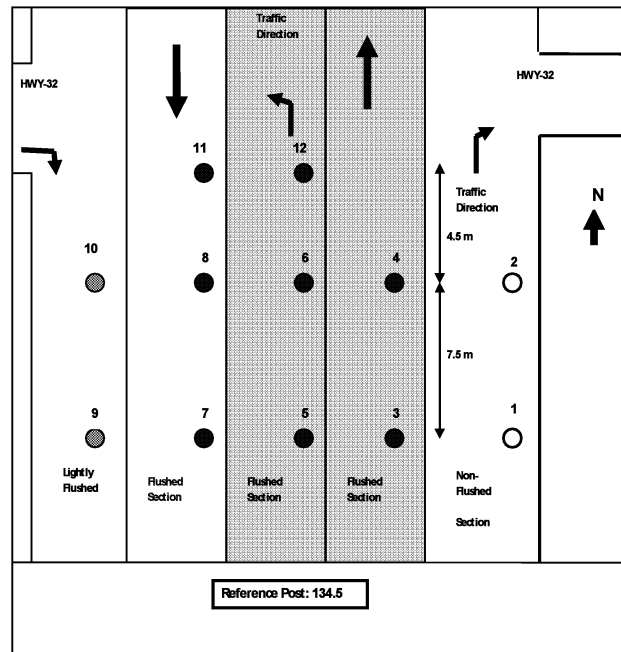
Fig. 6. Effects of Traffic Loads on Flushing Severity.

Fig. 6 illustrates an example of the effect of traffic on the severity of flushing. The figure shows the intersection of Highway 15 and 32 where several cores were extracted. The extension of Highway 32 eastward is a farm-market unpaved road while Highway 15 is a two-lane asphalt highway. In this location, cores 1 and 2 were drilled in the right-turn lane to the low-volume-road with low or no heavy traffic. Cores 3 and 4 were drilled in the through north-bound lane which experiences slightly heavier traffic. Cores 5, 6, and 12 were drilled in the left-turn lane to Highway 32 with heavy traffic. Cores 7, 8, and 11 were drilled in the south-bound lane with heavy traffic. Cores 9 and 10 were drilled in the right-turn from Highway 32 into Highway 15 with a lower heavy traffic volume than that of a through traffic lane. Binder and D/B parameters were not significantly different between flushed and non-flushed cores at this

location. Binder stiffness was softer for low flushing severity than for high flushing severity, indicating that flushing generally increased as traffic volume increased.
