# Feasibility of Using Accelerated Thin Bonded Concrete Overlay for CRCP Spalling Repair

**Abstract:** A pilot trial under the Fully Optimized Road Maintenance (FORMAT) project of using thin bonded concrete overlay (BCO) for spalling repair was carried out in the Houston district on SH 146 near Baytown, Texas. In this paper, the practical considerations for the use of thin BCO in terms of the procedures and the material characteristics key to its success are presented, and the effectiveness of this treatment for spall damage in continuously reinforced concrete pavements (CRCPs) is assessed through varied field tests performed before and after the application. Also addressed is its feasibility relative to traffic control and user cost, existing pavement condition, and future maintenance factors as it is considered in the decision-making process of Strategic Analysis of Pavement Evaluation and Repair (SAPER) software. The results show that the application of the treatment combination (i.e. full depth repair, milling, and thin BCO) cost-effectively extended pavement life, improved load carrying ability with reduced user delay, and improved safety control and that it is an innovative

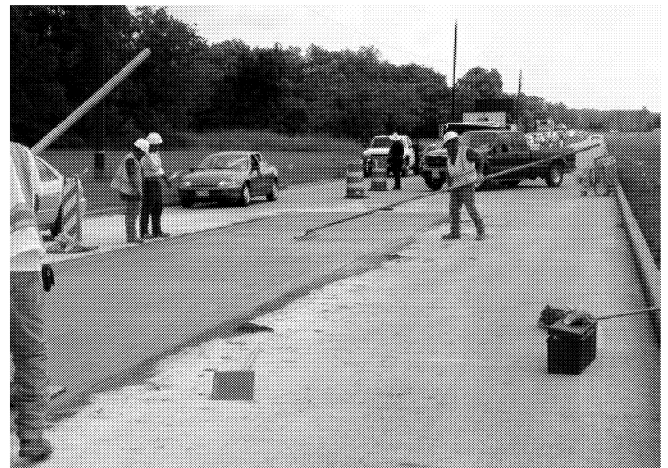
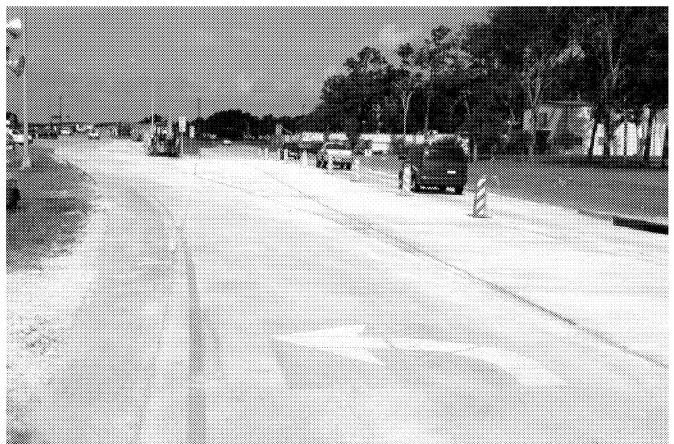
**Fig. 1.** Work Zone Condition of the Field.

(a) During Paving.

(b) During Curing.

construction. It can be seen that during concrete paving (shown in Fig. 1(a)) a long traffic queue was tended to build up, while after concrete paving (shown in Fig. 1(b)) the queue reduced but the vehicle speed was still low.

During the milling and laydown operations, travel and time delay data relative to user costs was collected at various times. This data tended to suggest that, construction activities can have significant impact on the flow of traffic through the work zone [13]. Fig. 1 shows the different work zone conditions during different stages of

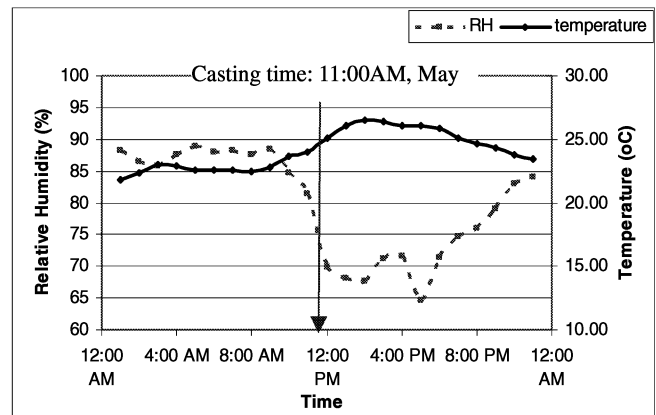
(a) Relative Humidity and Temperature vs. Time

During its early age, the pavement is most susceptible to thermal changes, drying winds, and to other adverse environmental conditions. Therefore, climatic factors significantly affect the development of delaminations, spalling, and other distresses in BCO systems at an early age [17, 18]. A weather station was used to collect weather data in the field that consisted of relative humidity, temperature, solar radiation, wind direction, and wind speed. Fig. 3(a) and 3(b) record the trends of relative humidity, temperature, solar radiation, and wind speed as a function of time from 1am to 11pm on May 8<sup>th</sup> 2004, respectively. Relative humidity showed an inverse relationship with temperature, i.e. higher temperature associated with lower relative humidity. Solar radiation level reached the highest value at 2pm, where the wind speed showed a big variation with the time.

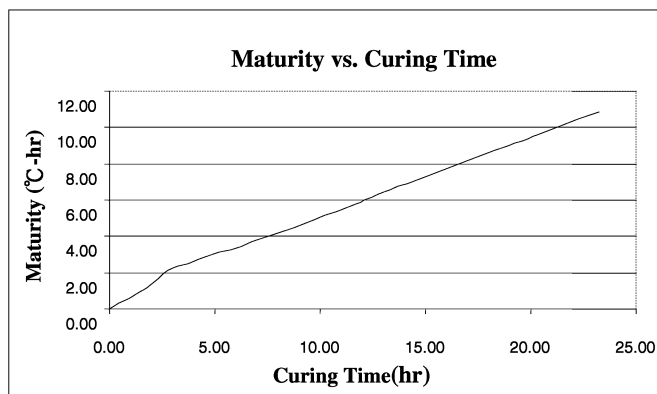
Fig. 4. Maturity vs. Curing Time of Concrete.

readings were useful to assess the quality of the curing. The development of maturity with curing time by the Nurse-Saul formulation [18] is shown in Fig. 4. It can be seen that the maturity increased with curing time.

The concrete maturity at the interface between the old and new concrete is critical to the bonding at the interface. Maturity was based on both temperature and moisture available at the interface, which require the use of moisture meters and thermometers. Time of setting was also determined and correlated to maturity. Moisture

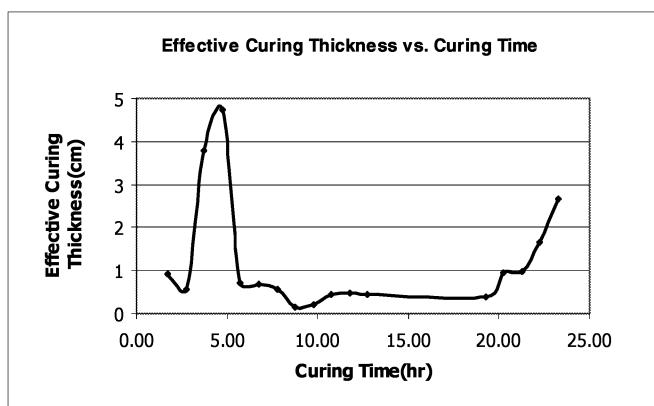
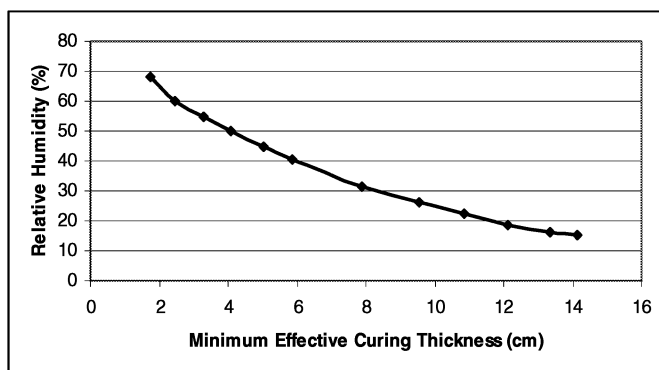
Fig. 5. Effective Curing Thickness of Concrete.

(a) ECT vs. Curing Time.

(b) Relative Humidity vs. Minimum ECT.

Effective curing thickness (ECT) can be described as the equivalent layer of concrete that would provide the same degree of curing as the curing medium. The thicker the effective curing thickness is, the larger the difference in humidity between the surface and immediately above the surface and the better the curing quality, which suggests ECT can be used as an indicator of curing quality [18]. Fig. 5(a) illustrates the trend of ECT with curing time.

It can be seen that ECT increased during a few hours after concrete placement when bleeding was underway, and then decreased afterward. From Fig. 3(b), it can be seen that the ambient relative humidity varied from 65% to 75% during 5 to 9 hours after placement. Correspondingly, from Fig. 5(b) which illustrates the minimum required ECTs under different relative humidity based on the authors' previous research, the required ECT should range from 1.3 to 2.0cm (0.5inch to 0.8inch) to ensure adequate bond at the interface between the old and new concrete. However, Fig. 5(a) shows that the actual ECT during this period was less than 1cm which indicates that this period was very critical to the concrete performance.

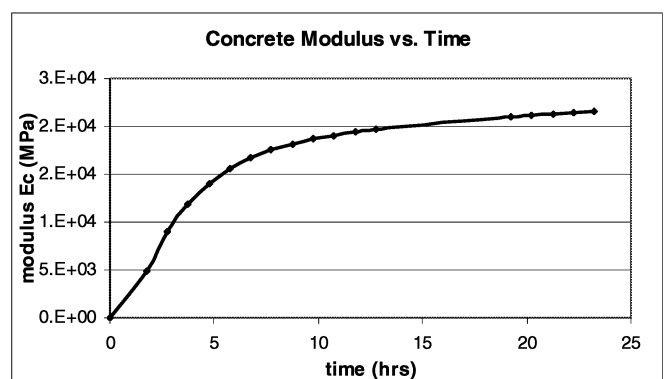
Fig.7. Concrete Modulus Development with Time.

The associated shear stress was determined as the product of drying shrinkage and concrete modulus assuming the new concrete is completely restrained against movement by the underlying concrete. The shear stress and strength with respect to the time were depicted in Fig. 8(b), which shows the shear strength increased greatly with the increase of the time. The shear stress varied with the time and also during the critical period discussed before (5 to 9 hours after casting) and two small peak values of the shear stress were observed. However, at any time period, the shear stress didn't reach the shear strength, which indicated that there was no delamination at the interface till 20 hours after casting.
