Laboratory Testing of Asphalt Surface Treatments for Airfield Pavements

John F. Rushing¹⁺ and Joe G. Tom, Jr.²

Abstract: The U.S. Army Engineer Research and Development Center conducted a study to provide recommendations for evaluating asphalt surface treatments for airfield pavements. The evaluation included an analysis of laboratory testing procedures to provide quantitative predictive performance capabilities. This paper contains testing results and provides guidance on selecting appropriate surface treatments based on laboratory testing procedures. Results indicate that ASTM D 2939 is appropriate for determining a product's fuel resistance. Calculations of the International Friction Index (ASTM E 1960) provided an effective quantitative procedure for predicting a product's impact on pavement friction. Tests performed to predict a product's ability to prevent oxidation and to predict delamination were inconclusive

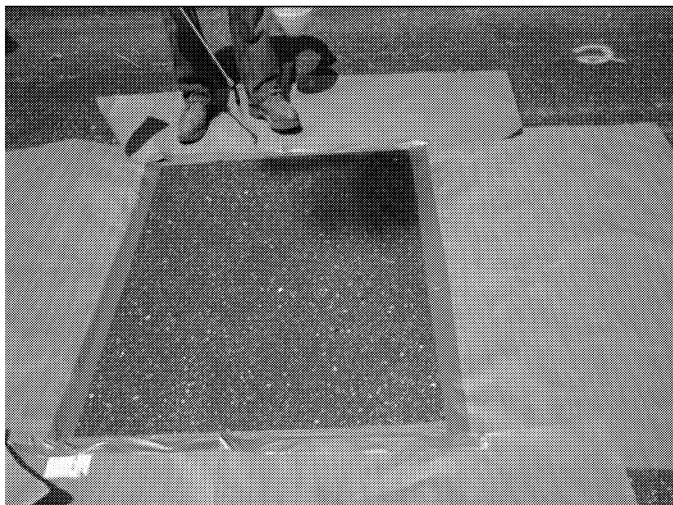
Fig. 1. Applying a Surface Treatment with a Garden Sprayer.

For this study, friction and texture characteristics were tested on 0.9 by 1.2m (3 by 4ft) surface patches. Various surface treatments were placed onto a pavement of approximately 25 years in age. No traffic was applied to the pavement during the test. In addition to

Test sections for this portion of the study were located on an unused pavement section at the U.S. Army Engineer Research and Development Center (ERDC) Vicksburg site. The pavement surface was cleaned by sweeping prior to any product application. Sections were marked for product placement by taping the treatment area and painting numeric identifiers by each section. Liquid products with an allowable viscosity were sprayed onto the pavement surface using a 3.8 liter garden sprayer (Fig. 1). Other products were applied using a squeegee (Fig. 2). Some products were measured to a specific quantity. Others were placed onto the surface until the

pavement was thoroughly coated. Rejuvenators were spread onto the surface using the squeegee and then blotted with paper towels to remove excess material.

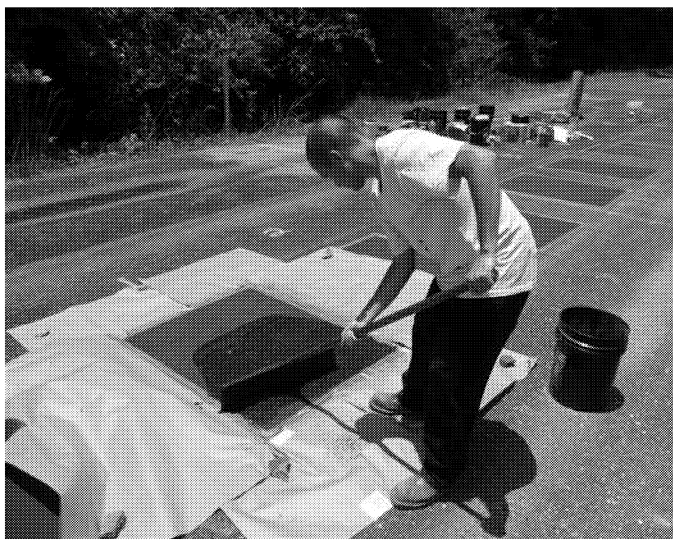
Fig. 2. Placing an Asphalt Sealer with a Squeegee.

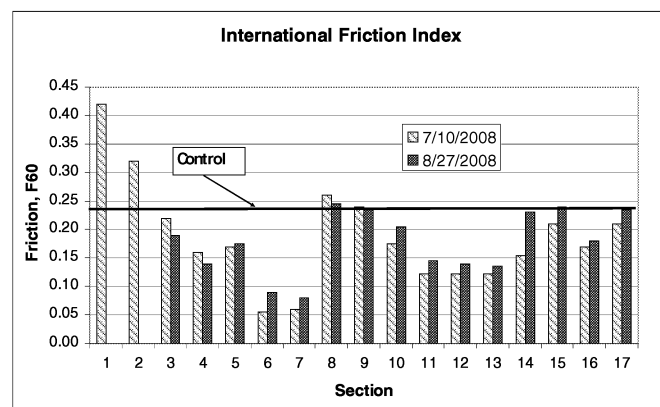
Fig. 4. International Friction Index.

Fig. 4 shows the majority of the surface treatments caused at least a slight decrease in the frictional characteristics of the pavement. The treatments that increased the friction of the pavements were those that contained large aggregates and created a more textured

surface. Contrary to previous results [4], sample patches treated with rejuvenators did not show as large of a decrease in skid resistance as expected. Although some of the patches treated with rejuvenator materials did show some decrease in friction (14, 15, and 17), others (8 and 9) did not show any marked decrease in frictional characteristics. The method of friction testing, however, could cause the unexpected readings for the rejuvenator patches. Moreover, the DFT tests friction by applying water to the surface of the test patches. The application of water during testing could remove material that did not penetrate the surface during the 24hrs curing time and lessen the effect of excess residue on the skid resistance of the treated surfaces. In spite of possible inaccuracies due to testing methods, the rejuvenated test patches that had some initial decrease in skid resistance did show an increase in friction in the later test date, as expected from Shoenberger’s test results [4].

Test patches treated with surface coverings not containing large aggregate materials (3-7 and 10-13) were found to have a larger amount of friction loss compared to rejuvenator-treated and

untreated pavements. These findings are in agreement with previous research that has shown seal coats with little to no large aggregates lower the skid resistance of pavements in comparison to untreated pavement [4]. Although the use of large aggregates in surface covering treatments may increase the surface friction of a pavement, these treatments also increase the danger of FOD damage to aircraft operating on airfield pavements with larger aggregates being removed by severe traffic loads.

The results from the DFT and CTM tests give the frictional characteristics of pavements in terms of the IFI. For this study, the IFI was used to address the effects of the surface treatments on the skid resistance of the pavement. The tests showed, in agreement with previous studies, surface coverings with large aggregates increase the skid resistance of the pavement; whereas, surface coverings without sufficient amounts of large aggregates substantially lower the skid resistance in comparison to untreated pavements. On the other hand, pavements treated with asphalt rejuvenators had only a marginally lower skid resistance than non-treated controls, possibly due to inherent features of the testing method.

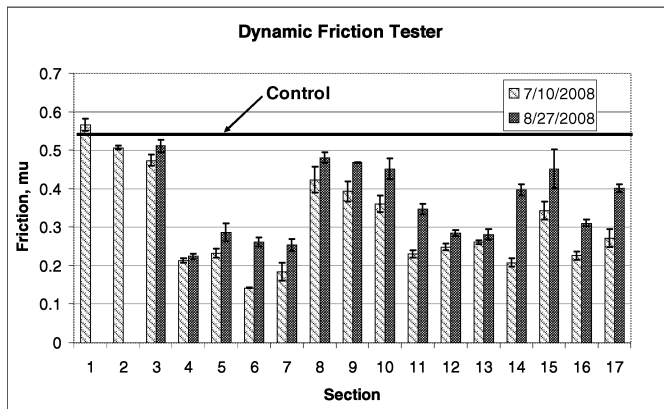
Fig. 5. Dynamic Friction Tester Results.

The combined use of the DFT and the CTM resulted in the determination of the friction characteristics of a sample pavement. The coefficient of friction for the sample pavements is taken by the DFT at 0, 20, 40, 60, and 80km/hr. As per ASTM 1960, the International Friction Index (IFI) can be calculated by correlating the friction determined at 20km/hr with a speed constant of wet pavement friction (S_p) to a friction value at 60km/hr (F60). The speed constant is determined from the mean profile depth of the sample pavement. The results of the regressions for the pavements tested can be seen in Fig. 4 with a description of each section in Table 4. In Fig. 4, the control line represents the average baseline for IFI for the unmodified pavement used in the testing. Figs. 5 and 6 show the results for the DFT at 60km/hr and the CTM for each section. The DFT data for the 60km/hr tests were selected for presentation because this speed closely relates to the current criteria for measuring friction values on airfield pavements. The error bars in both figures represent one standard deviation for three data points from each test.

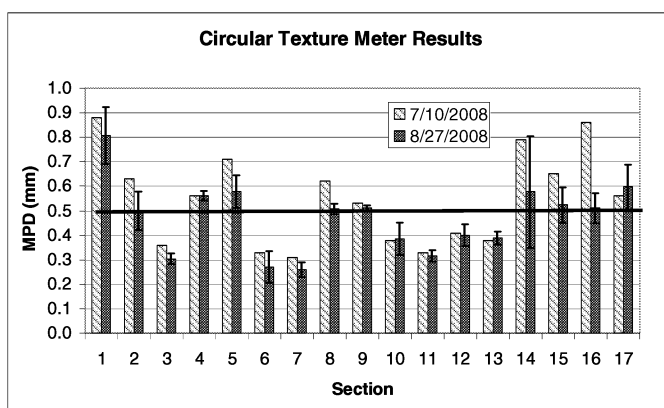
Fig. 6. Circular Texture Meter Results.
