# Radar Technique Application in Structural Analysis and Identification of Interlayer Bonding

**Abstract:** The paper discusses opportunities for evaluation of the asphalt pavement interlayer bonding quality with the use of GPR (Ground Penetrating Radar) techniques. The laboratory measurements were performed using a single 2 GHz, air-coupled, impulse antenna (in the simple reflection configuration) for the collection of synthetic samples representing idealized models of horizontal delamination. The measurements provided estimations of the antenna resolution in detecting cracks under dry and wet conditions. This analysis of the “double reflection” being a distinguishing feature of delamination allowed to formulate an important conclusion as to the critical limitations of the measuring system and as to the adequate methods of signal processing and interpretation. The field investigations consisted of GPR measurements (using the same antenna) along selected road sections and collecting drilling cores at locations associated with strong double reflections. The preliminary inspection of the drilling cores provided some insight as to the what laminae causing the double reflections are i

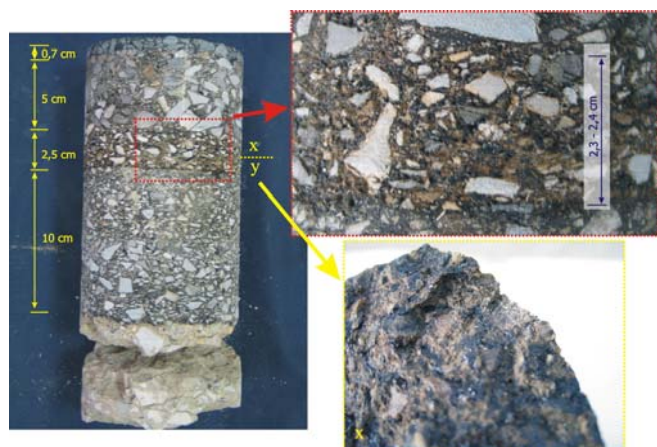
**Fig. 7.** Core 3a – a 2.5 cm Thick, Pumice-structure-layer at the Depth of Approx. 6 cm. The Cross-section of the Layer shows the Results of Aggregate Degradation and Insufficient Amount of Asphalt Binder.

The sample marked 3a shows a cross-section of the road surface with a horizontal zone, positioned at the depth of 6 cm, whose properties differ considerably from those of the layers situated directly above and beneath. The thickness of this zone is approximately 2.5 cm, and its porous structure is similar to that of pumice. Upon breaking the layer, humid, clay-like residues of light-brown color were identified, filling the space between and surrounding the aggregate grains. The residues are most probably a product of degradation of lime aggregate grains subjected to water and low temperatures. One may assume that the atmospheric carbon dioxide contained in the asphalt-penetrating water has considerably

facilitated erosion of the carbonate aggregates used for the construction of the road surface, and the light-brown discoloration suggests the participation of oxygen in the oxidation of minerals with a ferrous compounds content. In addition, insufficient amount of asphalt binder has been discovered (which has been washed out by water), which formed, in the broken sample, a cobweb instead of having the form of a uniform film surrounding the individual grains. No lack of bonding between the asphalt layers has been identified, and the core has been broken, in the zone with mineral abnormalities, under laboratory conditions, without the use of any tools, which proves the mechanical weakening of the zone in question.
