Performance Evaluation of Military Airfield Pavement Drainage Layers

Abstract: A performance evaluation of drainage layers was conducted during the period of August to November 2008 at three U.S. Air Force bases to determine if the in-place performance justifies their required use on military airfield pavements. Evaluation procedures included the artificial introduction of water into the pavement structure and observation of outflow. Flow and time measurements were recorded and analyzed to determine if the provided permeability of each drainage layer satisfies the current design criteria. Results from this evaluation showed that design and construction, as well as maintenance have important roles in the functionality of airfield pavement drainage layers. Several pavement areas tested were not functioning properly. However, permeability rates through the drainage layers meeting the aggregate gradation specifications were within acceptable limits. It was concluded that the use of drainage layers in military airfields is beneficial, but should be required only on areas where climatic conditions represent a potential of water entering and causing problems in the pavement system. Histo

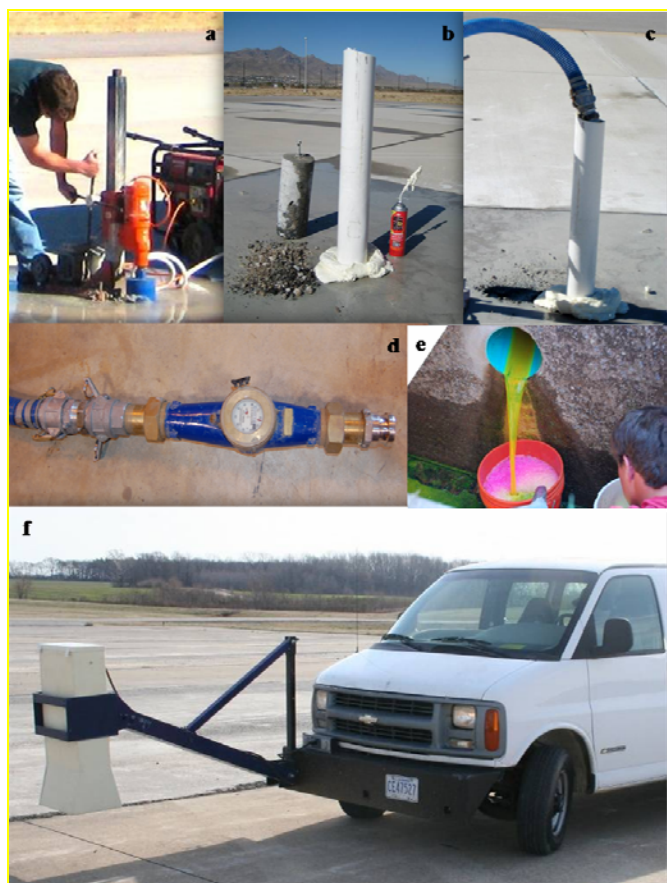
Fig. 1. Field testing procedures.

A core rig with a cutting barrel diameter of 15.2 cm (6 in.) and length of 38.1 cm (15 in.) was used to core a cylinder through the pavement surface (Fig. 1-a). For asphalt concrete pavements, base course above the drainage layer was removed by hand. Pavement

material was removed until the drainage layer was exposed. A 1.5 m (5 ft.) section of PVC pipe with a diameter of 10.2 cm (4 in.) was placed on top of the drainage layer. The gap between the pipe and the pavement in the core hole was sealed with polyurethane foam (Fig. 1-b). After the foam set (20 min), a 5.1 cm (2-in.)-diameter hose was placed in the PVC pipe (Fig. 1-c). The hose was connected to a flowmeter (Fig. 1-d) that was connected to the water truck. PVC pipe was filled with water to increase the pressure head. The initial flowmeter reading was recorded. Water flow was initiated and allowed to reach the maximum that the drainage layer could accommodate without water overflowing the PVC pipe. The water flow was then reduced to a steady-state rate, maintaining a water column inside the PVC pipe. Water volume and time were recorded periodically as water was allowed to flow into the pavement. Once water outflow was observed at the nearest outlet, a tracer dye was added to the inflowing water and, when observed, the outflow water was collected at the outlet structure (Fig. 1-e). The following times were recorded: (1) time water input began, (2) time when outflow was first observed, (3) time when tracer dye was added, (4) time when tracer dye outflow was observed, (5) time when water inflow was stopped (6) time when observed water outflow ceased.

During the test, a GPR manufactured by Pulse Radar, Inc. with a 1 GHz antenna (Fig. 1-f) was used to establish moisture lateral extents underneath asphalt concrete pavements. The moisture lateral extents were monitored by collecting measurements in a grid pattern to plot a two-dimensional moisture lateral extent. The changes in the moisture lateral extents were documented during saturation of the drainage layer.

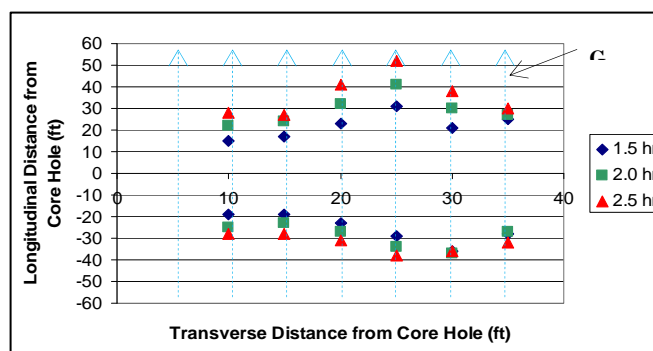
Fig. 2. Moisture Profile in Drainage Layer from GPR Data.

collected by scanning the parallel lanes at different time intervals. The lanes were spaced 1.5 m (5 ft.) apart. Data were analyzed to determine the point in the lane where moisture was detected by the GPR. Additionally, the point was recorded where moisture was no longer detected. Recording these points for each lane provided the ability to create a 2-dimensional map of the moisture in the drainage layer. The moisture profiles for the pavement section at different time intervals are shown in Fig. 1. Only the points along the lane where the appearance and disappearance of moisture are noted, and all of the space between these points contain moisture. These data were used to determine the width of the area through which the water was moving. As the water was introduced into the core hole, it spread uniformly in all directions. As equilibrium in flow was established, the plume of water was fixed as indicated in Fig. 2. Only small changes in the width were observed in subsequent scans.

The GPR did an excellent job at detecting the location of water moving through the drainage layer. The flow was observed to form a plume of approximately 15.2 m (50 ft.) nearest the core hole and approximately 27.4 m (90 ft.) at a distance of 7.6 m (25 ft.) from the core.

After approximately 2.5 hours and the introduction of 3,407 L (900 gal.) of water, moisture was noticed emerging from the daylighted edge of the drainage layer. However, GPR data indicated

that the water had reached the pavement shoulder after 1.5 hours of flow.

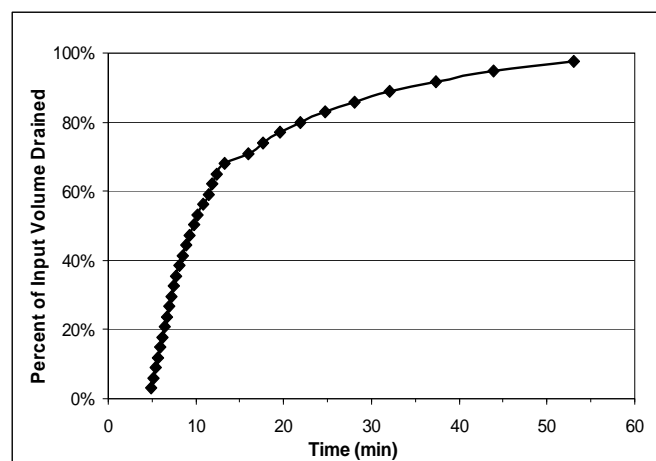
Fig. 3. Percent of Total Input Volume Collected at the Outlet Over Time.

A total volume of 644 L (170 gal.) was added from the time of the addition of tracer dye until the water inflow was stopped. The tracer dye outflow was collected with a 19-L (5-gal.) bucket, and then the time to fill each bucket was recorded. This procedure was used to determine time required to drain the porous layer. It can be seen from Fig. 3 that the input volume (644 L (170 gal.)) was almost completely drained in about one hour, which indicates that water retention was minimal or negligible. No flow obstruction was observed.
