Radar Technique Application in Structural Analysis and Identification of Interlayer Bonding

Abstract: The paper discusses opportunities for evaluation of the asphalt pavement interlayer bonding quality with the use of GPR (Ground Penetrating Radar) techniques. The laboratory measurements were performed using a single 2 GHz, air-coupled, impulse antenna (in the simple reflection configuration) for the collection of synthetic samples representing idealized models of horizontal delamination. The measurements provided estimations of the antenna resolution in detecting cracks under dry and wet conditions. This analysis of the “double reflection” being a distinguishing feature of delamination allowed to formulate an important conclusion as to the critical limitations of the measuring system and as to the adequate methods of signal processing and interpretation. The field investigations consisted of GPR measurements (using the same antenna) along selected road sections and collecting drilling cores at locations associated with strong double reflections. The preliminary inspection of the drilling cores provided some insight as to the what laminae causing the double reflections are in real

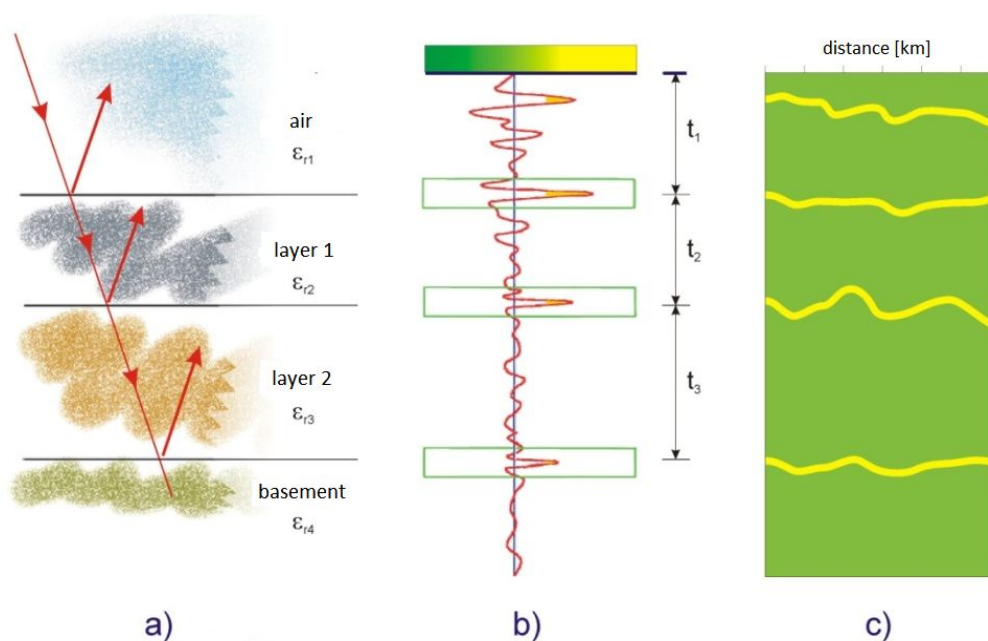
Fig. 1. GPR System Signal Recording Principle: a) Simplified Image Depicting Passage of the Electromagnetic Impulse through Air and Subsequent Layers 1, 2 etc., Combined with the Generation of Signals Reflected by Interlayer Borders; b) Reflected Signal Received; c) Simplified Radar Measurement Echogram.

The measurement systems as used in geo-radar based methods are made up of an impulse generator that forms impulses of prescribed frequency and power, an antenna that emits the electromagnetic impulse towards the surveyed object and a recording module that processes and records the reflected signals. The electromagnetic impulses produced are short, focused wave packages in the meaning that the head package (head signal) is characterized by a high

amplitude and is composed of a low number of oscillations (e.g. three semi-periods), while the long persisting following fluctuations called the tail of the signal (created as a result of internal reverberations in the antenna) are characterized by a relatively low amplitude. Thanks to such a simple shape and large amplitude of the head package the copy of the impulse can be easily identified what means also that the moment at which it arrives at the receiving antenna may be precisely positioned in time.

The electromagnetic impulses emitted towards the surveyed structure penetrate the subsequent layers of materials characterized by varying dielectric properties, and are subject to partial reflection at the borders of the individual layers. This allows estimating the time of return and the amplitude of the signal reflected at the borderline between materials of various dielectric properties (Fig. 1). Those properties are, from the radar technique's point of view, crucial and clearly determine the form of the image obtained.

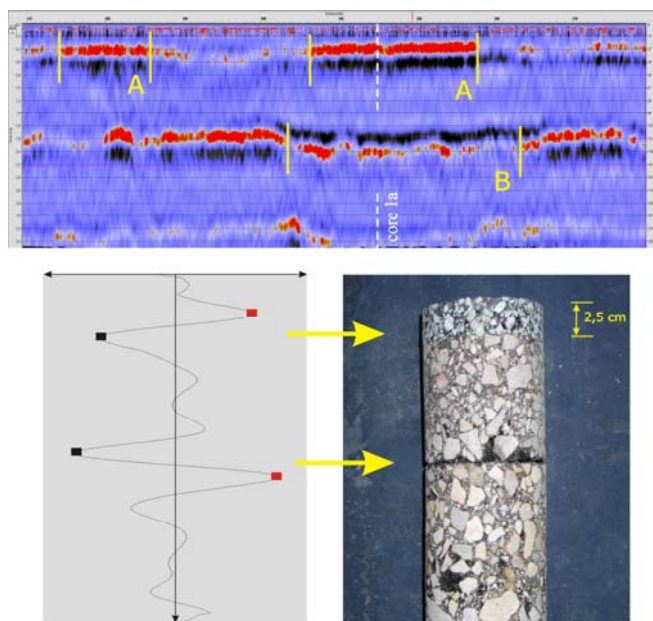
Fig. 4. Case 1. Fragment of an Echogram (Processed with the Use of the Standard “Background Removal” Procedure), Obtained During Measurements Conducted at a Section of Varying Characteristics and Accompanied by the Location of the Drill, Oscilloscope Image from the Radar Measurement at the Drill Location (Time Window 3.5ns) and a Photograph of Core La (Not to Scale). The Echogram Shows Changes in Amplitude and Sign of the Reflections corresponding to the Bonding between the Abrasive and Binding Layers (Sections with the Length of 7-10 m Marked as A) and Lack of Bonding between the Upper and Lower Binding Layers (Section Marked as B).

The echogram recorded at this section is presented in Fig. 4. One can clearly see two depth ranges at which alterations of the recorded signal may be observed. The first one, approximately 0.4-0.6 ns from the surface, represents the border between the abrasive layer and the upper bonding layer. In this range one may notice appearing and disappearing pairs of positive-negative reflections (red-black, A), with the largest amplitudes recorded at two sections with the length of 7-10 m each. The echogram suggests delamination at the connection between the abrasive and the binding layers. Meanwhile, apart from the visually observed, increased amount of free spaces in the lower regions of the abrasive layer, the collected surface sample has failed to indicate more considerable damage. In the second range, 1.6-2.2 ns from the surface, a double reflection may be observed with its sign changing along the profile. The time position of this reflection corresponds to the border between the upper and the lower binding layers, which is confirmed by the core. The negative double reflection as seen in the oscilloscope image (black-red, B) from the sample collection location indicates that there is no bonding between the layers in the middle of the cross-section. Such a position of reflections also indicates that there is no water in the bonding zone. Opposite polarity of the signal at adjacent sections suggests, meanwhile, that there is water in the bonding zone. It may be the case that there is no bonding between both asphalt layers at those sections, but such a claim would have to be verified by collecting pavement samples. Nevertheless, data from the drill (core 1a) and archive data indicate that the problem of improper bonding between the bonding layers is typical for the entire section. The bonding between the layers is additionally subjected, at some locations, to water penetrating from the road lane divider. The echogram in question (Fig. 4) shows the reflection horizons positioned parallel to the outer surface of the asphalt. Therefore, the shape of reflection signals may be considerably distorted as a result of applying the standard “background removal” procedure, which makes the definition of the type of the reflection (single or double) and its sign (positive or negative) uncertain (see Case 4), and any assumptions must be verified by inspection of the core.

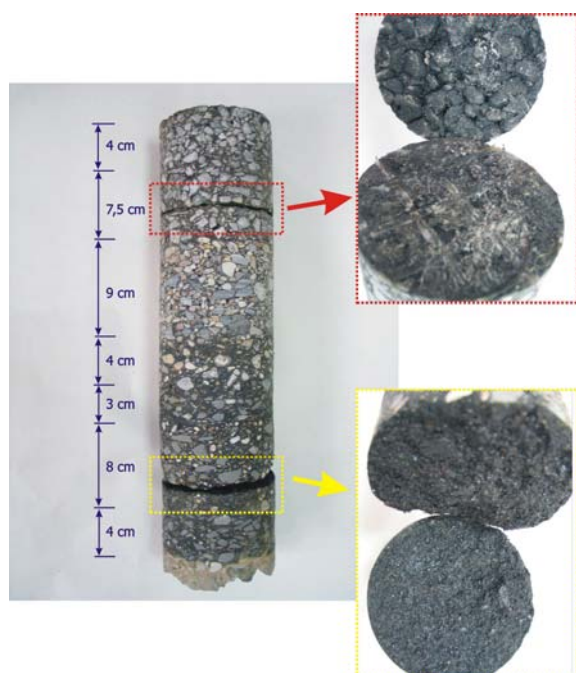
Fig. 5. Cores (diameter 10 cm) Collected in 2009. a) Core 2a Collected at the Right-hand-side Wheel Track, in Which the Lack of Bonding between Upper and Lower Bonding Layers is Visible; b) Core 2b Collected in the Center of the Hard Shoulder – the Bonding of Layers has been Visually Assessed as Good.

surface, with a fiberglass anti-crack netting built-in (at the depth of 9 cm) (core 2a, Fig. 5a). The use of netting without a special anti-slip layer has weakened the bonding of the layers and has resulted, due to heavy truck traffic (presently about 2700 axles 100 kN/lane/day), in the loss of bonding between them.

For comparison, a sample from the hard shoulder was collected at the same location (Fig. 5b, core 2b). Based on visual assessment it was determined that the bonding is good at the depth of the anti-crack netting.

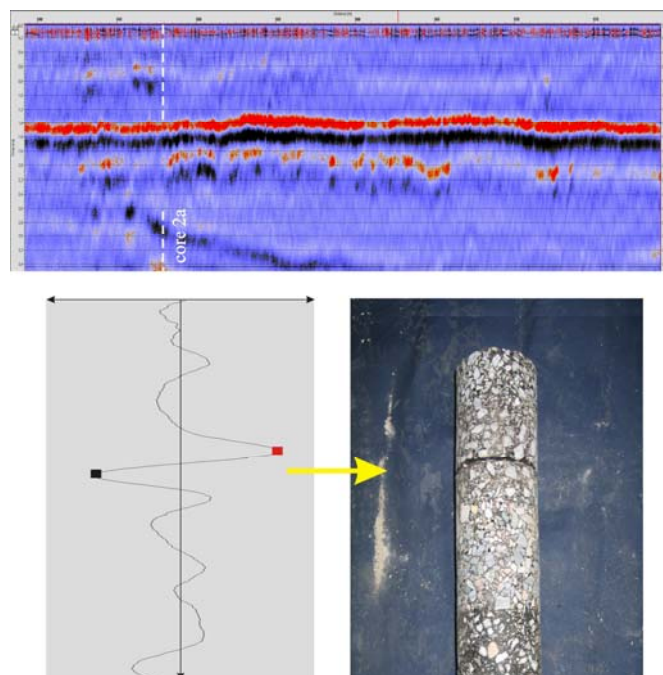
Fig. 6. Case 2. Fragment of an Echogram (Processed with the Use of the Standard “Background Removal” Procedure), Obtained During Measurements Conducted at a Section of Uniform Characteristics (Double Reflection Recorded at the Same Depth Under the Surface Throughout the Entire Section) and Accompanied by the Location of the Drill, Oscilloscope Image from the Radar Measurement at the Drill Location (Time Window 3.5ns) and a Photograph of Core 2a (Not to Scale). A Pair of Reflections Visible at the Entire Section, Corresponding to the Loss of Bonding between the Binding Layers at the Depth of the Built-in anti-crack Netting.

The echogram registered at this section is presented in Fig. 6. A clear positive, double reflection is visible throughout the entire section, 1.2-1.8 ns from the surface, representing a lack of bonding between asphalt layers at the depth at which the anti-crack netting is built in. The type and sign of the reflection indicate the presence of water at the bonding. However, due to the contrast between wave velocity of glass and asphalt, one may suspect that such a shape of the recorded signals is caused by fiberglass netting, causing a local decrease in the velocity of the electromagnetic wave.

Similarly to Case 1, reflection horizons are parallel to the outer surface of asphalt. Therefore, application of the standard “background removal” procedure makes the definition of the type of the reflection (single or double) and its sign (positive or negative) uncertain (see Case 4), but the interpretation has been confirmed by with the help of the core.

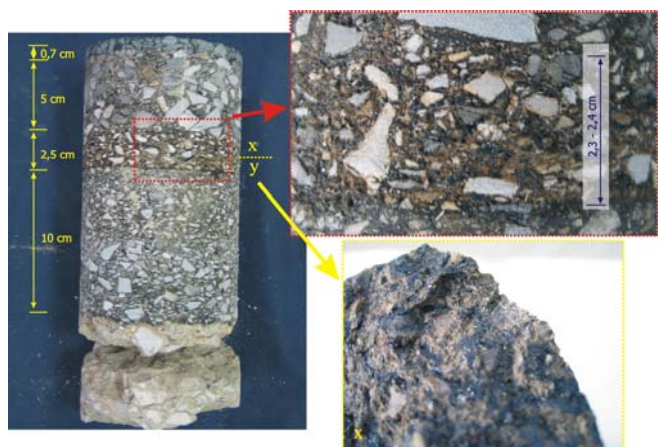
Fig. 7. Core 3a – a 2.5 cm Thick, Pumice-structure-layer at the Depth of Approx. 6 cm. The Cross-section of the Layer shows the Results of Aggregate Degradation and Insufficient Amount of Asphalt Binder.

The sample marked 3a shows a cross-section of the road surface with a horizontal zone, positioned at the depth of 6 cm, whose properties differ considerably from those of the layers situated directly above and beneath. The thickness of this zone is approximately 2.5 cm, and its porous structure is similar to that of pumice. Upon breaking the layer, humid, clay-like residues of light-brown color were identified, filling the space between and surrounding the aggregate grains. The residues are most probably a product of degradation of lime aggregate grains subjected to water and low temperatures. One may assume that the atmospheric carbon dioxide contained in the asphalt-penetrating water has considerably

facilitated erosion of the carbonate aggregates used for the construction of the road surface, and the light-brown discoloration suggests the participation of oxygen in the oxidation of minerals with a ferrous compounds content. In addition, insufficient amount of asphalt binder has been discovered (which has been washed out by water), which formed, in the broken sample, a cobweb instead of having the form of a uniform film surrounding the individual grains. No lack of bonding between the asphalt layers has been identified, and the core has been broken, in the zone with mineral abnormalities, under laboratory conditions, without the use of any tools, which proves the mechanical weakening of the zone in question.

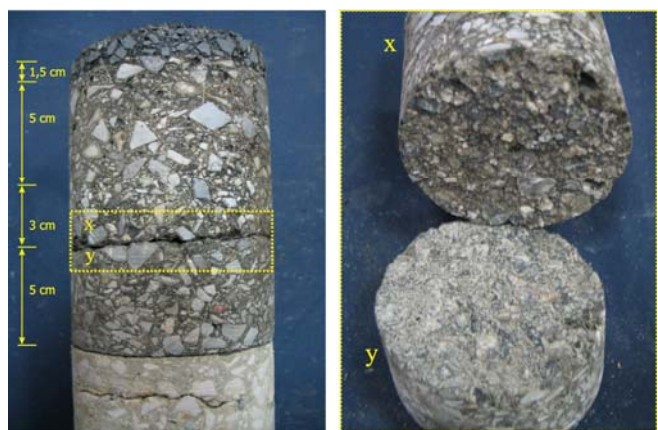
Fig. 8. Core 3b – No Bonding in the Binding Layer, Fully Exposed Aggregate Grains at Connection Surfaces (Asphalt Binder).

The sample marked 3b shows a cross-section of the surface structure in which there is a crevice between the asphalt layers, at the depth of approximately 9 cm. In the delamination zone one may clearly notice the lack of asphalt binder and fully exposed aggregate grains, probably a result of water penetration. The condition of individual layers, their quality and structure raise no reservations upon visual inspection.

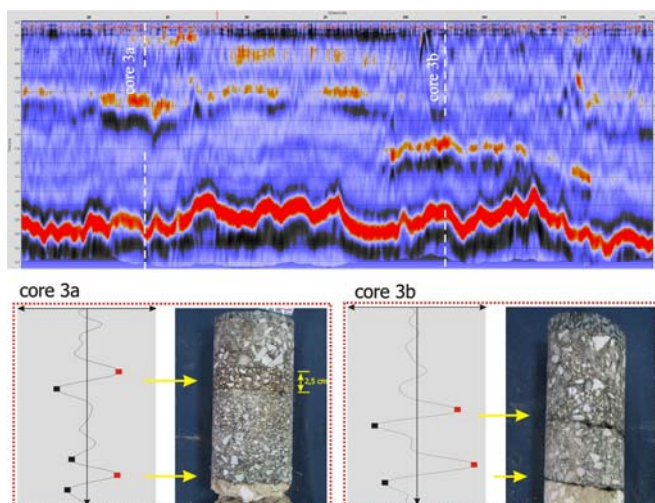
Fig. 9. Case 3. Fragment of an Echogram (processed with the use of the standard “background removal” procedure), Obtained During Measurements Conducted at a Section of Varying Characteristics (reflections are not parallel to the surface, at the entire length of the section) and Accompanied by the Location of Drills, Oscilloscope Image from the Radar Measurement at the Drill Locations (time window 3.5 ns) and a Photograph of Cores 3a and 3b (not to scale). Yellow Echogram Markers Indicate Changes in the Structure of the Pavement.

Radar data recorded at this section (Fig. 9) clearly pinpoints the location at which the structure of the surface has been modified. The first section from which core 3a was collected is characterized by a

fairly stable signal. A positive double reflection is visible at this section at the depth of 0.8-1.4 ns from the surface. According to the adopted interpretation methodology, such a radar image should indicate a poor, humid bonding between the layers of asphalt. But the image of core 3a (Fig. 7) indicates that the bonding of all asphalt layers is at least good. The examined cross-section is characterized by an uncommon, structure-wise, zone with advanced material degradation of thickness about 2.5 cm, positioned at the depth of 6-8 cm. It is this zone that “generates” a signal whose characteristic is similar to that obtained at locations where complete delamination has taken place. One may assume that this highly porous zone was saturated with water when the measurements were made.

At the other section, just as in the case of the first one, a double positive reflection is visible recorded 1.7-2.1 ns below the surface. This reflection represents delamination at 2/3 of the lower binding layer thickness (Fig. 8, core 3b). The double positive reflection visible in the echogram (peak layout, downwards: positive-negative, colors: red-black) indicates that there is no bonding between the layers and that water fills the delamination zone at the distance of approximately 10 m of the road surface.

In Case 3 identification of the type and sign of strong double reflections poses no such serious doubts as in Cases 1 and 2, even after the echogram being processed with the use of the standard “background removal” procedure, as the layout of the horizons responsible for the generation of those reflections is not parallel, at long sections (comparable to the length of the entire cross-section) to the road surface (see Case 4).
