# Feasibility of Using Accelerated Thin Bonded Concrete Overlay for CRCP Spalling Repair

**Abstract:** A pilot trial under the Fully Optimized Road Maintenance (FORMAT) project of using thin bonded concrete overlay (BCO) for spalling repair was carried out in the Houston district on SH 146 near Baytown, Texas. In this paper, the practical considerations for the use of thin BCO in terms of the procedures and the material characteristics key to its success are presented, and the effectiveness of this treatment for spall damage in continuously reinforced concrete pavements (CRCPs) is assessed through varied field tests performed before and after the application. Also addressed is its feasibility relative to traffic control and user cost, existing pavement condition, and future maintenance factors as it is considered in the decision-making process of Strategic Analysis of Pavement Evaluation and Repair (SAPER) software. The results show that the application of the treatment combination (i.e. full depth repair, milling, and thin BCO) cost-effectively extended pavement life, improved load carrying ability with reduced user delay, and improved safety control and that it is an innovative

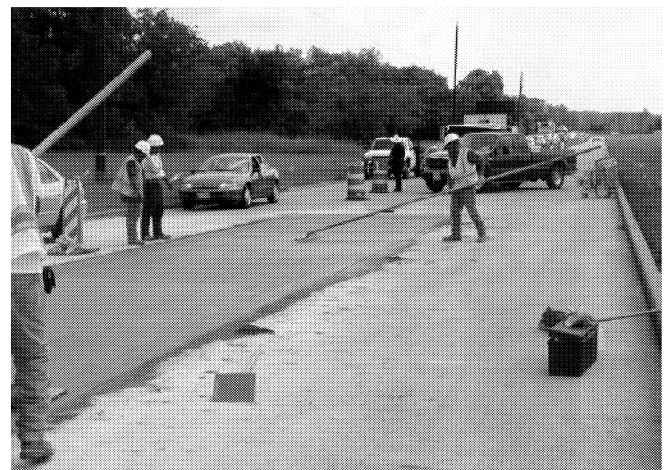
(a) During Paving.

**Fig. 1.** Work Zone Condition of the Field.

construction. It can be seen that during concrete paving (shown in Fig. 1(a)) a long traffic queue was tended to build up, while after concrete paving (shown in Fig. 1(b)) the queue reduced but the vehicle speed was still low.
