# Accelerated Loading Evaluation of Foamed Asphalt Treated RAP Layers in Pavement Performance

**Abstract:** An accelerated pavement testing (APT) experiment was conducted to evaluate field performance of foamed asphalt-treated reclaimed asphalt pavement (RAP) layers used in a flexible pavement structure under typical southern Louisiana highway conditions. The APT experiment consisted of three full-scale flexible pavement sections with different base layers: a regular good-performing crushed stone base and two foamed asphalt-treated RAP bases containing different RAP percentages. Laboratory test results indicated that the two foamed asphalt RAP materials exhibited the higher potential of moisture susceptibility, had less resilient moduli, and were more prone to permanent deformation than the crushed stone base material considered. The APT results showed that the foamed asphalt base test sections had excellent early performance, but both failed by a suddenly sharp increase in permanent deformation when the APT load level was increased. A shakedown analysis revealed that the foamed asphalt treated RAP base materials could have lower shakedown stress thresholds than that of the crushe

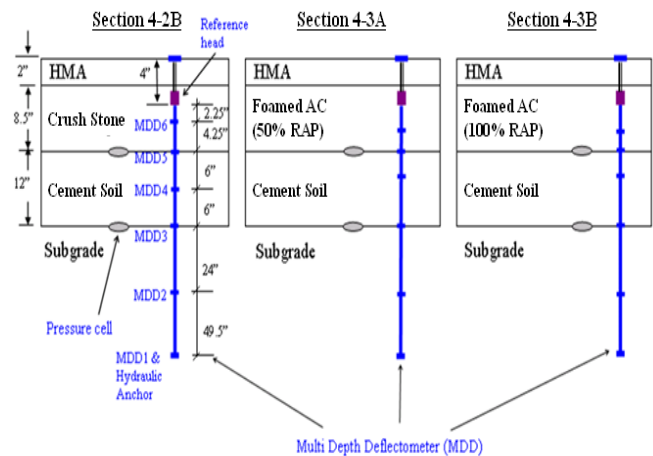
Fig. 1. Pavement Structures of APT Test Sections (1 in. = 2.54 mm).

Normal construction procedure was followed to construct test sections for this APT experiment. Fig. 1 presents pavement structures of test sections considered. Each test section is 13-ft. wide and 107.5-ft. long. As shown in the figure, all sections consist of a 2.0-in. HMA wearing course, an 8.5-in. base course, and a 12-in. cement-treated subbase layer over an A-6 embankment subgrade. A good-performing, 3/4 -in. Superpave HMA mixture, typically used as a wearing course for intermediate/high volume pavements in Louisiana [12], was selected as the surface layer of test sections. The subbase layer is an in-place 8 percent (by volume) cement-treated A-6 soil. The details of different base materials will be presented in the subsequent section.

Fig. 1 also shows the field instrumentation layout of each test section. For each test section, two Geokon 3500 pressure cells were embedded at two depths directly along the centerline: one at the bottom of the base layer and the other on top of the subgrade. One multi-depth deflectometer (MDD) with six potentiometers (deformation measurement sensors) was installed on each test section at a distance of 4.5 ft. away from the pressure cell location along the centerline. More details about those instrumentation devices can be found elsewhere [13].

As shown in Fig. 1, three base layers were considered: a crushed limestone base on section 4-2B and two foamed asphalt (FA) treated RAP bases on sections 4-3A and 4-3B. The crushed limestone base of 4-2B is a regular LADOTD Class-II base course with a specified gradation listed in Table 1 [12].

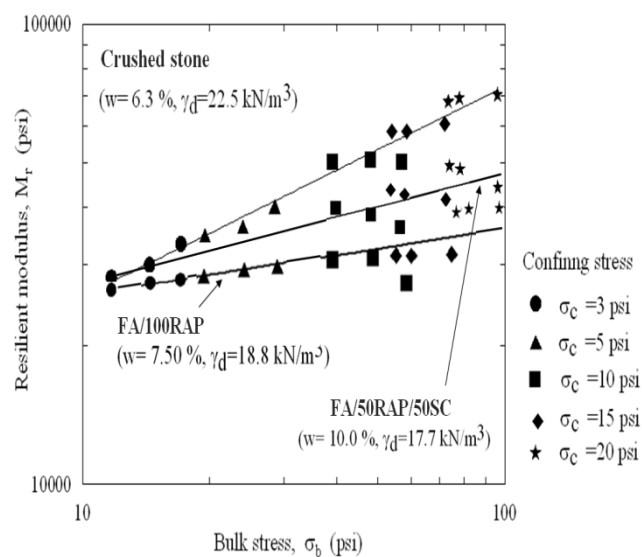
Fig. 2. Resilient Modulus of Base Materials (1 psi = 6.89 kPa).

Laboratory repeated loading triaxial (RLT) tests were used to determine the resilient moduli ( $M_r$ ) of base materials considered in this study [15]. All laboratory test samples were remolded from material collected in the field and compacted in the laboratory at their in situ conditions and the  $M_r$  tests were performed at an ambient temperature of  $25 \pm 1^\circ$ . Fig. 2 presents the resilient moduli results varied with bulk stress ( $\sigma_b$ ) and confining stress ( $\sigma_c$ ) for the crushed stone and two foamed asphalt base materials of this study. As shown in Fig. 2, the  $M_r$  of crushed stone increased as either  $\sigma_b$  or  $\sigma_c$  increased. This observation indicates that an increase in the  $\sigma_b$  would increase frictional resistance among crushed stone particles and an increase of  $\sigma_c$  would decrease material dilatational properties. Fig. 2 further indicates that the resilient properties of the two foamed asphalt-treated RAP materials were slightly different from the crushed stone. When buck stress  $\sigma_b$  is less than 20 psi (138 kPa) and confining stress  $\sigma_c$  is constant, the  $M_r$  values for both foamed asphalt RAP materials would increase as the increase of  $\sigma_b$ . However, when  $\sigma_b$  becomes greater than 20 psi, those  $M_r$  values tended to decrease as the  $\sigma_b$  increases. This may be attributed to the decrease in friction among the foamed-asphalt treated RAP particles because of the smooth asphalt coating around them, especially under high  $\sigma_b$  levels. Meantime, as the confining pressure increases, the  $M_r$  of foamed-asphalt treated RAP increases. Such a behavior is similar to that of a crushed stone. Overall, the evaluated crushed stone material showed higher  $M_r$  values than both foamed- asphalt treated RAP materials.

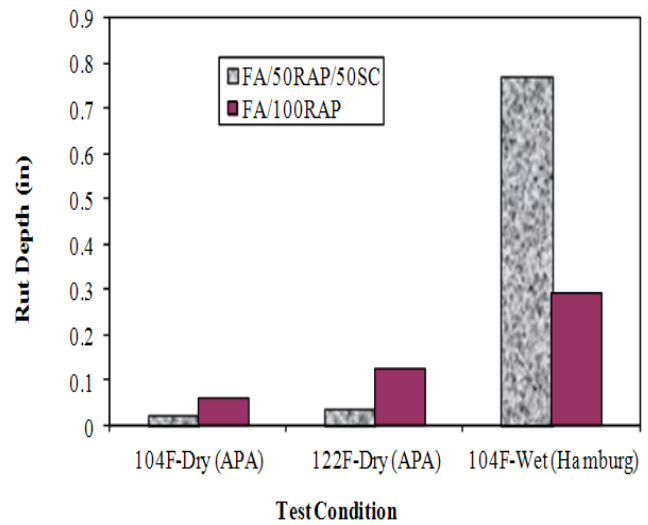
Fig. 4. Results of Loaded Wheel Tracking Tests (1 in. = 2.54 mm).

To capture rutting performance under both dry and submerged conditions, two types of loaded wheel tracking (LWT) tests: Hamburg Type Wheel Tracking and Asphalt Pavement Analyzer (APA) were conducted on slab samples fabricated from the foamed asphalt treated base materials used in the APT experiment. The Hamburg test is considered as a torture test that produces damage by rolling a 71.1 kg (158 lb) steel wheel across the surface of a slab that is submerged in water for 20,000 passes. The APA device simulates actual road conditions by rolling a metal wheel over a rubber hose pressurized at 100 psi for 8000 cycles. The APA test was conducted under dry conditions at 104 and 122°F, while the Hamburg test was performed with a submerged water temperature of 40°C (104°F). Fig. 4 presents the average rut depths obtained from the results of those tests. It is noted that the rut depths increased with increasing the temperature. At the same testing temperature, the foamed asphalt-treated RAP materials accumulated much higher rut depth under the wet condition in the Hamburg Type Wheel Tracking test compared to the dry condition in the APA test. Such results clearly indicate that both foamed asphalt RAP materials possess potential moisture susceptibility problems. Furthermore, it may be also noticed from Fig. 4 that the FA/50RAP/50SC material tends to exhibit much greater moisture susceptibility than FA/100RAP material.

It is believed that the insufficient shear strength and low shake-down threshold are largely associated with low water resistance of the foamed asphalt RAP materials. Laboratory LWT rut tests showed that both foamed asphalt materials exhibited low water resistance when tested in a submerged condition and the FA/50RAP/50SC material exhibited even greater moisture

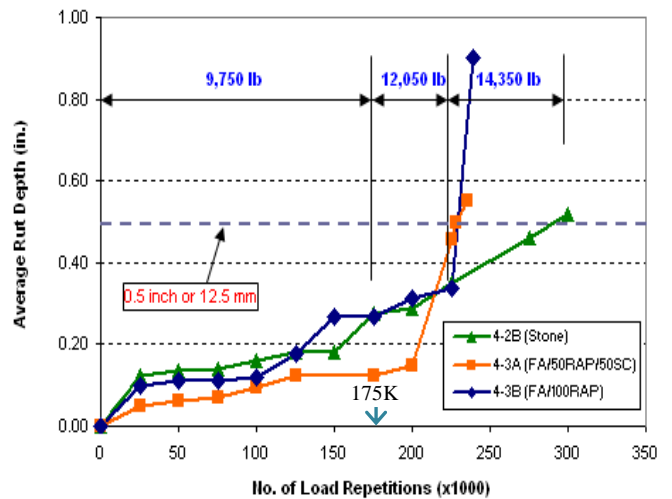
Fig. 5. Measured Rut Depths on Test Sections (1 in. = 2.54 mm & 1 lb = 0.454 kg).

All three test sections had a rutting failure according to the failure criteria set for this experiment. Some severe localized cracks were observed on all sections after the APT test. It should be noted that those localized cracks directly resulted from large surface depression developed nearby. Fig. 5 presents the average measured rut depths with the number of load repetitions for the three sections tested. As shown in the figure, for the first 175,000 load repetitions when the load level was at 9,750-lb, it is apparent that the two foamed asphalt base sections (4-3A and 4-3B) performed similarly as or even slightly better than the stone section. The mean rut depth at 175,000 repetitions was 0.12-in. for the FA/50RAP/50SC section, 0.24-in. for both the FA/100RAP and stone sections. Subsequently, as the load levels increased, both foamed asphalt sections exhibited a significantly higher rutting accumulation rate than the stone section. In the end, the FA/50RAP/50SC section (4-3A) reached the rutting limit (i.e. an average rut depth of 0.5-in.) at 228,000 repetitions, whereas, the FA/100RAP section (4-3B) reached at 230,000 repetitions, and the stone section (4-2B) reached at 282,000 repetitions. If the ALF repetitions are converted into the 18,000-lb Equivalent Single Axle Load (ESAL) numbers based on the fourth power law [16], the corresponding ESAL numbers for sections 4-2B, 4-3A and 4-3B would be 786,000, 411,000 and 356,000, respectively. Obviously, the stone base section performed better than both foamed asphalt base sections in this study.

SN values for the stone section seems to be not as sensitive to the changes of ALF load levels, see Fig. 6(a). In general, the SN changes observed in Fig. 6(a) matched well with the rutting measurement curves shown in Fig. 5.

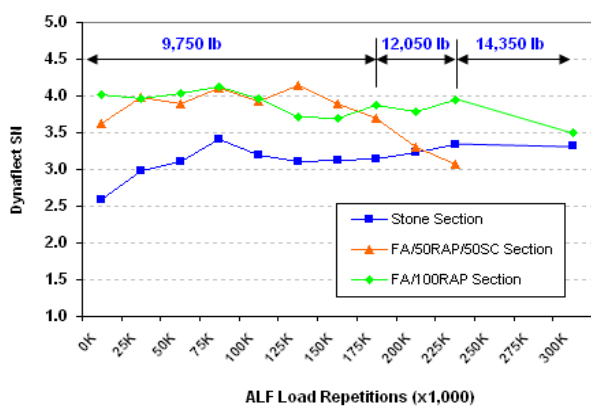
(a) Dynaflect SN Results

Fig. 6(a) presents ALF load induced progression of the average SN values for the three test sections evaluated. A higher SN value indicates greater structural capacity of a pavement. An initial increase in the SN values during the first 75,000 ALF passes or so may be attributed to the post construction densification of pavement layers and the corresponding material strength gains due to the curing. As expected, the overall SN values generally displayed a slightly decreasing trend (due to pavement deterioration) with the increase of load repetitions.

As shown in Fig. 6(a), prior to 175,000 loading repetitions, both foamed asphalt sections had higher SN values than the stone section (4-2B). After 175,000 repetitions, the SN for the FA/50RAP/50SC section (4-3A) began to decrease rapidly and eventually became lower than that of the stone section. Furthermore, due to the increase of ALF load levels, the SN for the FA/100RAP section also showed a sharper decrease after 225,000 repetitions. However, the change in

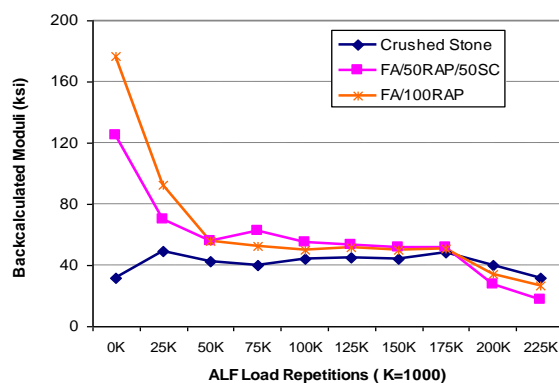
(b) FWD Backcalculated Base Moduli

Fig. 6(b) presents the FWD backcalculated moduli for the three base materials. As shown in the figure, the moduli for both foamed asphalt materials decreased rapidly as the load repetitions increased. However, the stone base used in section 4-2B seemed not very sensitive to the load repetitions, whose moduli varied slightly with the increase of load repetitions. It is noted that both foamed asphalt bases had a higher backcalculated modulus than the stone base up to 175,000 load repetitions, Fig. 6(b). The rapid decrease in backcalculated moduli of those foamed asphalt materials, although partially due to the temperature effect, might be explained by internal material damages due to the load and environmentally effects (e.g. the moisture).

Statistical summary results showed that the average vertical stresses developed at the bottom of base layers were 18.6-, 10.2- and 9.6- psi for the stone base section (4-2B), the FA/50RAP/50SC section, and the FA/110RAP section, respectively. Meanwhile, the corresponding average stress values on the top of subgrades were 0.7-, 0.4 and 0.3- psi, respectively. This indicates that a higher vertical stress distribution generally existed within the stone section (4-2B) than those within the two foamed asphalt sections under the ALF load of 9,750-lb during the first 175,000 repetitions. It further confirmed the FWD backcalculated base modulus results as showed in Fig. 6(b). Unfortunately, no further comparison could be made after 175,000 repetitions.

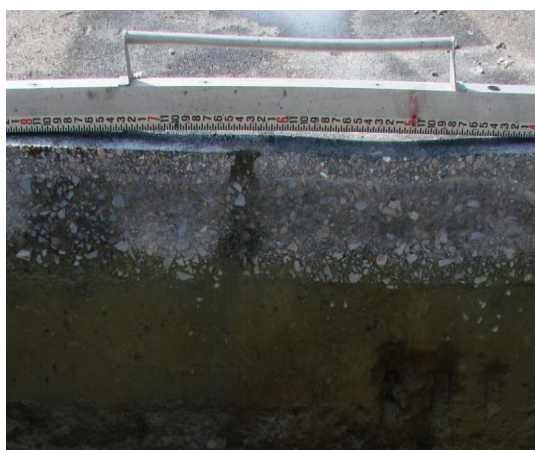
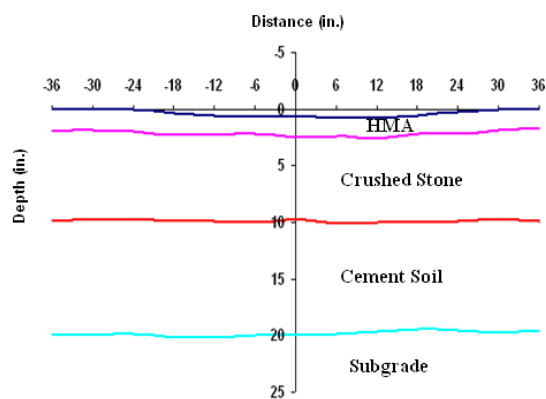
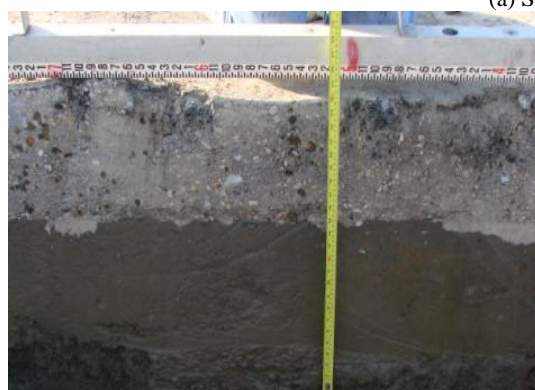
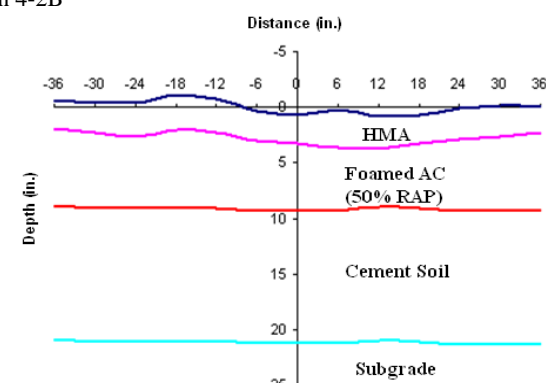
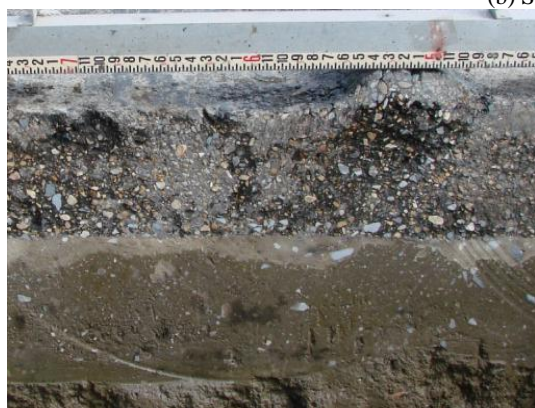
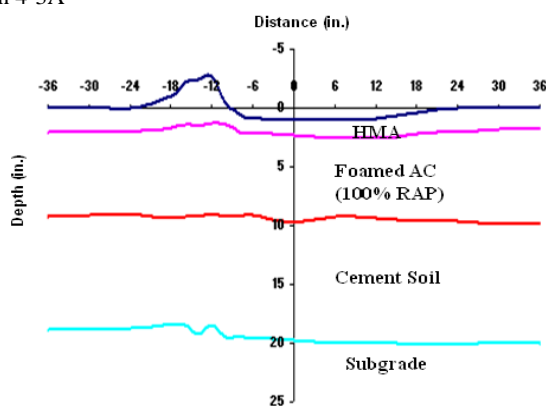
**Fig. 8.** Post-Mortem Trench Results (1 in. = 2.54 mm).

Fig. 8 presents results of post-mortem trenches saw-cut at a severely-distressed station on each test section. As shown in Fig. 8(a), the transverse rutting profile of section 4-2B (the stone base section) primarily resulted from further densification (depression below the original surface) of the HMA and crushed stone materials under the load. However, the rutted profiles on the foamed asphalt sections (Fig. 8(b) and 8(c)) included not only the densification but also heave deformation (permanent deformation above the original surface). The heave deformation was generally found rooting from the base layers of sections 4-3A and 4-3B, indicating both foamed asphalt treated base materials had a shear failure under the increased ALF load levels. Obviously, such shear failures are associated with insufficient shear strength, which further demonstrates that both foamed asphalt treated RAP base layers should have a lower shakedown load threshold than that for the crushed stone base in 4-2B.

susceptibility than the FA/100RAP material. The FA/100RAP mixture consisted of 48.6 percent RAP, 48.6 percent recycled soil cement, and a design air void of 20.3 percent. Such a high design air void plus high percentage of recycled soil cement material had potentially produced a weak structural skeleton for the FA/50RAP/50SC mixture (i.e. too much soil particles); thus, only 2.8 percent foamed asphalt content seemed not able to bond the weak aggregate skeleton effectively (which can cause the water susceptibility problem). Consequently, when high load-induced stresses transformed to this material under a moisture rich pavement condition, it lost its strength and started to develop a shear failure.

On the other hand, the trench profiles also revealed that the cement soil and subgrade layers on the FA/100RAP section (4-3B) did show some permanent deformation development. This observation is consistent with the MDD results in Fig. 7(c). Several months after construction, small droplets of asphalt binder material seeped up through the surface of section 4-3B (with FA/100RAP base). The initially spotted asphalt droplets, as shown in Fig. 9(a), became much more noticeable during the APT testing, and eventually caused significant surface distresses on section 4-3B (Fig. 9(b)). The FA/100RAP mixture contained 97.5 percent RAP and 2.5 percent foamed asphalt with a design air void of 15.3 percent. The

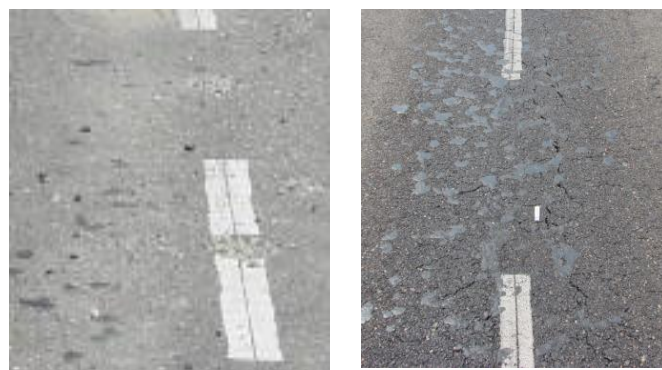
**Fig. 9.** Asphalt Droplets on Section 4-3B.

droplet binder material that had bled through the surface could be the aged foamed asphalt binder, or RAP binder, or a MC-250 cutback asphalt prime coat (applied at a rate of 0.25 gallons per square yard in the construction record), which indicated a possible over-asphalting problem for the FA/100RAP mixture design. Under the daily temperature change (especially during a summer), the free asphalt materials started to seep up through the top HMA layer. Such “seep-up” action not only caused a cosmetic problem, but also created many tiny crack paths inside the HMA mixture. Therefore, free surface moistures could have entered into the FA/100RAP base layer through those cracks, which gradually weaken the strength of the base material and thus cause a premature shear failure.
