# A Comprehensive Overview on Main Distress Mechanisms in Composite Pavements

**Abstract:** Fatigue cracking of cement-treated bases, instability rutting, top-down cracking, shrinkage cracking, reflective cracking and thermal fatigue cracking have been identified as the most common distresses affecting the service life of composite pavements, which consist of an asphalt course on top of a cement-treated base. These distresses prevent composite pavements from being considered long-life pavements, which are defined as pavements in which the structural elements may last indefinitely. This paper analyzes different factors leading to the initiation and propagation of the distress mechanisms, as well as the material properties required to improve the long-term performance of composite pavements.

**Key words:** Composite pavement; Cracking; Distress mechanism; Performance.

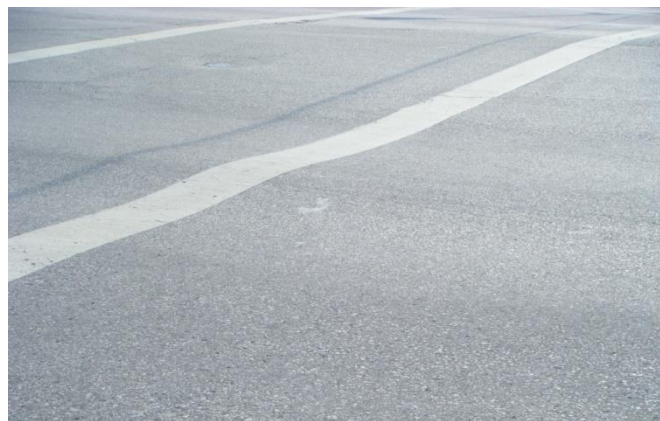
Fig. 1. Pavement with Severe Instability Rutting.

Analysis of measured tire contact stresses showed high shear stresses near the surface combined with low levels of confinement, which may explain the mechanism of instability rutting [15, 16]. Su et al. [17] also indicated that instability rutting is due to shear stresses developed within the asphalt concrete, especially in composite pavements where the asphalt surface absorbs the tangential deformations. Furthermore, Flintsch et al. [12] pointed out that the presence of a stiff base, which does not allow any significant vertical deformation to occur, causes the asphalt material to deform in order to absorb all the vertical strains. Thus, the stiffness of the base increases the potential for instability rutting and the subsequent rut depth.

Regarding the location of the distress, Quanliang et al. [18] found that the deformation mainly takes place in the asphalt binder course, at a depth that ranges from 4 to 10 cm. Moreover, they observed that layer thickness was not a major factor. By contrast, mixture properties, temperature, and traffic (both magnitude and rate of application) had higher effect on permanent deformation.

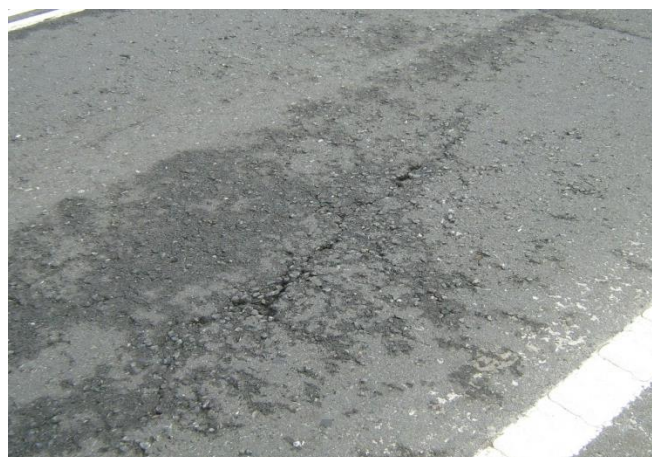
**Fig. 2.** Top-down Cracking Associated with Segregation

Thus, it can be concluded that top-down cracking is a distress related to the stresses developed at the pavement surface, the properties of the asphalt concrete (stiffness gradients and binder hardening), and placement conditions, especially segregation. The use of gradations more resistant to fracture and polymer-modified binders have shown improved performance in terms of top-down cracking [24, 27-29]. Additionally, placement conditions should be carefully considered to avoid cracking induced by segregation (Fig. 2).

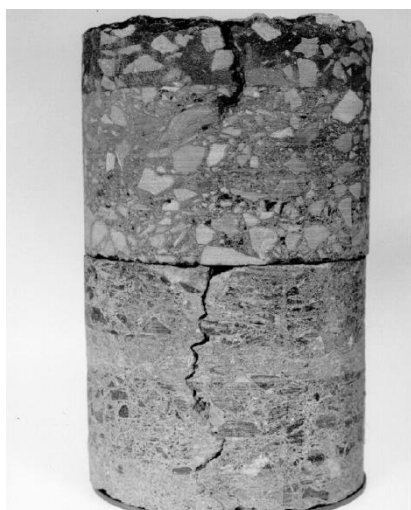
**Fig. 4.** Top-down Reflective Cracking [34].

Nernas and Nunn [34, 35] stated that reflective cracking in composite pavements can start at the surface (over the transverse

joints) and propagate downward through the asphalt concrete (Fig. 4). The results showed that top-down reflective cracking is due to thermal cycles rather than traffic loading, since the same cracking patterns were observed in sections with and without traffic.

Properties of the surface course are considered to govern the initiation of this type of cracking [34, 35]. The higher coefficient of thermal expansion of asphalt concrete, the higher thermal gradient at the surface and, especially, the aging of the binder (increase in stiffness) increase the maximum tensile stress induced by temperature drops, which is what leads to cracking. The reduction of asphalt course thickness and a higher joint spacing of the cement treated base (CTB) were found to increase the maximum tensile stress at the surface.
