# Sealing of paving stone joints

Mauro Coni \*, Silvia Portas, Francesca Maltinti, Francesco Pinna

*DICAAR, Department of Civil Engineering, Environment and Architecture, Faculty of Engineering, University of Cagliari, Via Marengo 2, 09123 Cagliari, Italy*

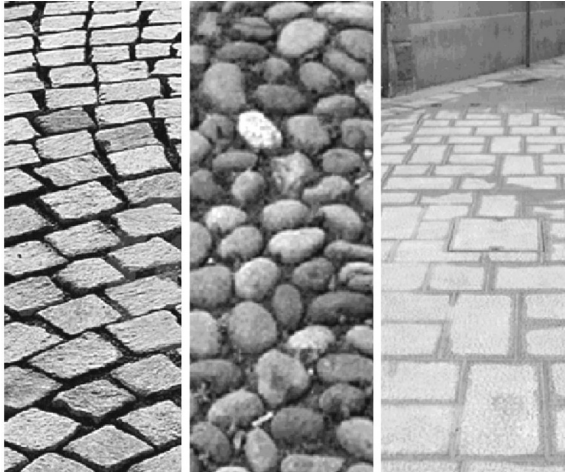
Fig. 1. Different types of stone pavements: sett, cobblestone, flagstones.

Different types of stone pavements are widespread in historic areas, and there are increasing amounts of new construction and requalification (Fig. 1). Paving blocks can be made of a variety of materials to satisfy functional and esthetic quality standards [1–3].

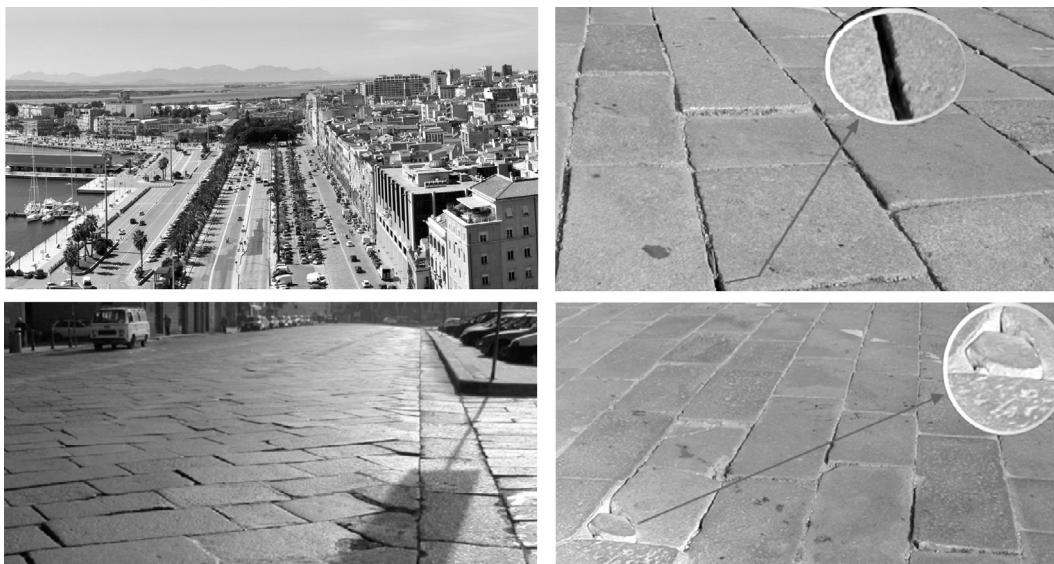
Fig. 2. The flagstone pavement on the Cagliari waterfront and typical distress.

The stone pavement in the historic waterfront of the city of Cagliari is frequently subjected to maintenance to restore disconnections between stones due to joint weakness (Fig. 2). The pavement is composed of blocks of granite squared in irregular prisms with maximum dimensions of  $40 \times 80 \times 19$  cm. The elements are set in a herringbone pattern with regular plots and characterize the valuable areas of many historic towns and villages in Italy. A gran-

The flagstone pavement of the Cagliari waterfront (Fig. 2, top left) was built in 1870, and it is currently protected as a monument and landscaped site. The street is one of the primary connections between the western and eastern parts of the metropolitan area, with 1800 vehicles/h in peak hours, 25% of which is heavy vehicles, mainly urban buses. The traffic creates frequent disconnections requiring maintenance activity. A critical event occurred in 2014. The fast passage of a bus dragged some of the

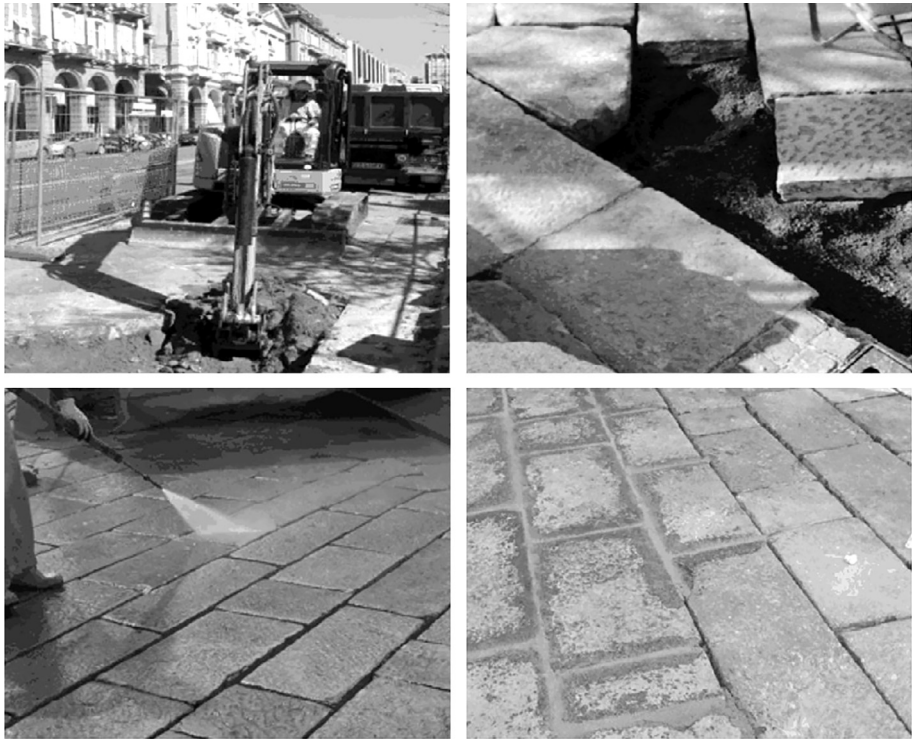
Fig. 5. Removal of the cement-sand deteriorated layer, cleaning, and joint sealing.

A proper bearing capacity value, with average  $M_d$  of 102.4 MPa, was found during the survey. Therefore, attention was focused on the underlying material and sealing joints. The implemented technique involved the following steps: (1) catalog and displace the flagstones; (2) remove the cement-sand deteriorated layer; (3) add new sand-cemented material and a metal mesh; (4) reposition the pre-existing flagstones, and (5) seal with the epoxy material (Fig. 5). Historical and Monumental Protection Authority supervised all phases of the pavement restoration.

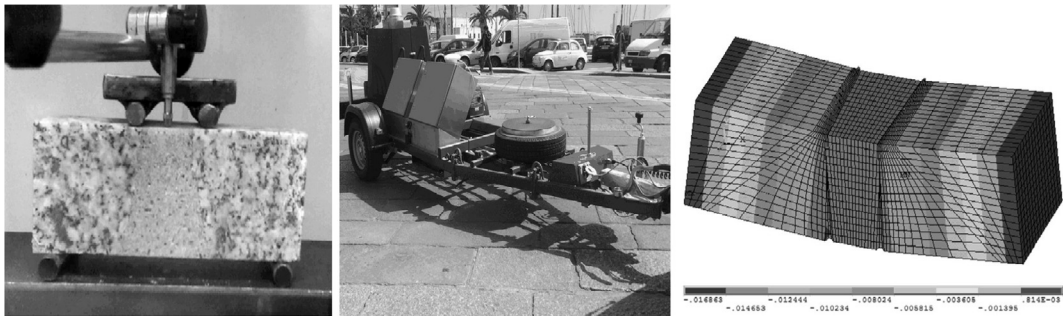
Fig. 7. (a) 4 point bending tests (4PBT); (b) FastFWD tests; (c) FEM simulations.

The study aimed to evaluate the structural capacity of the joints and to estimate the improvements of the stress and strain fields. Eight prismatic specimens at the joint were subjected to repeated cycles of the four-point bending test (4PBT). The new pavement was tested with 42 deflectometric drops performed with the FastFWD at three stress levels to evaluate the ability of a deflection basin with a specific geophonic configuration to return the load transfer efficiency (LTE) between adjacent elements. Finally, a series of FE simulations of the 4PBTs and the 2D pavement section subjected to the FWD dynamic load were conducted (Fig. 7).

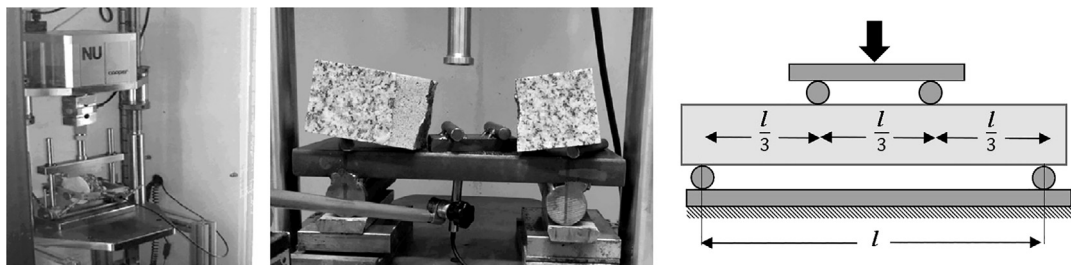
Fig. 8. Adapted NAT equipment, fatigue breakage and 4PBT scheme.

Fatigue tests were performed on five prismatic specimens with a nominal tensile stress of 1.67 MPa applied to the specimen. Granite flagstone samples were cut, sealed with resin, squared and rectified in the laboratory. The same process was not possible on joints sealed with sand-cement mortar because the cutting and preparation operations destroyed the samples, demonstrating the low adhesive capacity and fragility of joints made with sand-cement mortar.
