Evaluation of Fatigue (Alligator) Cracking in the LTPP SPS-6 Experiment

Abstract: The performance of Crack, Seat, and Overlay (CS&O) pavement sections is evaluated in terms of fatigue cracking (also known as alligator cracks). Data extracted from the Long Term Pavement Performance (LTPP) SPS-6 experiment were divided into two categories based on weather region, namely Wet-with-Freez (WF) and Wet-with-No-Freez (WNF). These data were then analyzed and regression models were developed. Data for pavement sections in California were evaluated separately leading to the development of a third regression model. In the WF region, thicker overlays did not appear help to minimize alligator cracks in sections with unbound bases. Sections with bound bases outperformed those with unbound bases in the WF region. Increasing the leveling course thickness from about 30.5 to 63.5mm helped to reduce alligator cracks in the California sections. Regression analyses suggest that sections in the WNF region will outperform their counterparts in the WF region and in California up to an age of approximately 12 years. The California sections are expected to exhibit approximately 56 percent alligator cracks a

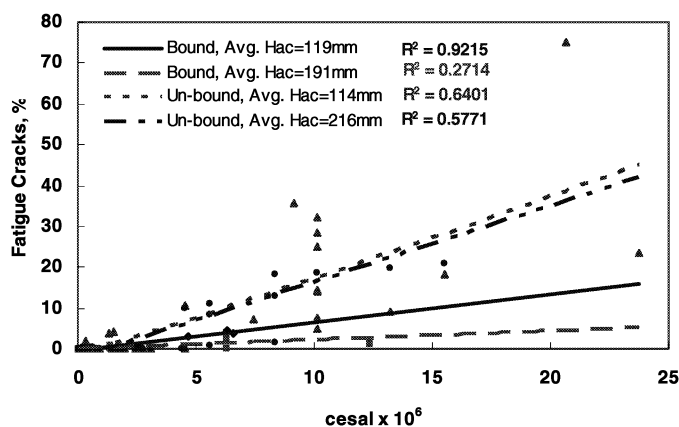
The percentages of fatigue cracks for CS&O sections in the WF region are presented in Fig. 1. As evident in Fig. 1, the thicker overlays did not help to minimize fatigue cracks in sections with un-bound bases. Sections in the WF region are susceptible to

Fig. 1. Fatigue Cracks for Sections with Different Overlay Thicknesses and Base Types in WF Region.

freeze-thaw cycles, which could have detrimental effect on un-bound bases in the thaw period. This could be the reason behind the trend evident in Fig. 1, which suggests that most of fatigue cracks in these sections could have developed due to the weak under-layers due to freeze-thaw cycles. However, for sections with bound bases, thicker overlays helped in minimizing fatigue cracks as depicted by trend lines in Fig. 1.

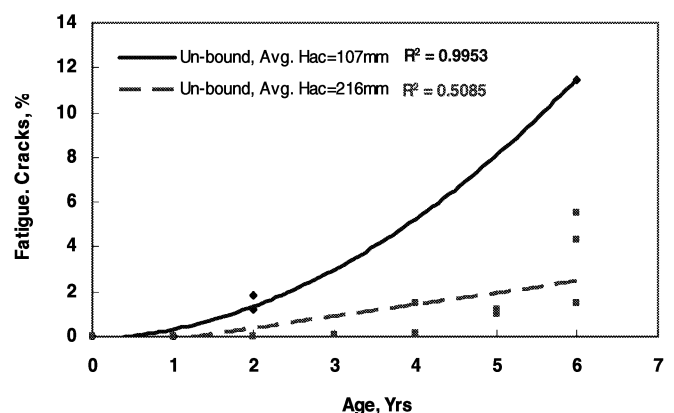
For the WNF region, only two sections with bound base had fatigue cracking data available. The two sections remained free of fatigue cracks for all four years of the condition survey. Therefore, only data for sections with un-bound bases are shown in Fig. 2. The thickness of the overlay played a significant role in minimizing fatigue cracks in sections built in the WNF region. In the absence of

Fig. 2. Fatigue Cracks vs. Age for Sections with Different Overlay Thicknesses in WNF Region.

traffic data for sections in the WNF region, the traffic effect could implicitly be included by looking at the age of the section. The thickness of overlay coupled with traffic loading are significant factors affecting fatigue cracks in CS&O sections with un-bound bases in the WNF region. However, since these sections are relatively young (average age equal to about 3 years), more data are needed to investigate the long term performance of these sections.

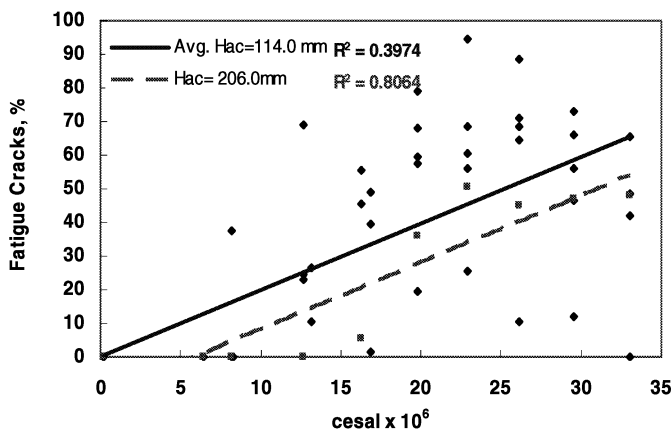
The effect of overlay thickness on fatigue cracks for LTPP-California sections is shown in Fig. 3. It is clear from Fig. 3 that thick overlays help in minimizing the percentage of fatigue cracks. Also, a thick overlay (about 206.0mm) retarded the appearance of fatigue cracks by approximately 6 million ESAL as compared with sections with average overlay thicknesses of about

Fig. 3. Fatigue Cracks vs. Traffic for LTPP-California Sections with Different Overlay Thicknesses.

114.0mm. Note that the average annual ESAL on these sections was calculated to be about 2.6 million, as shown in Table 1. For such a high level of traffic, a thick overlay would be needed to reduce and/or retard fatigue cracks. The thick overlay would limit tensile strain at the bottom of the overlay while protecting the under-layers.

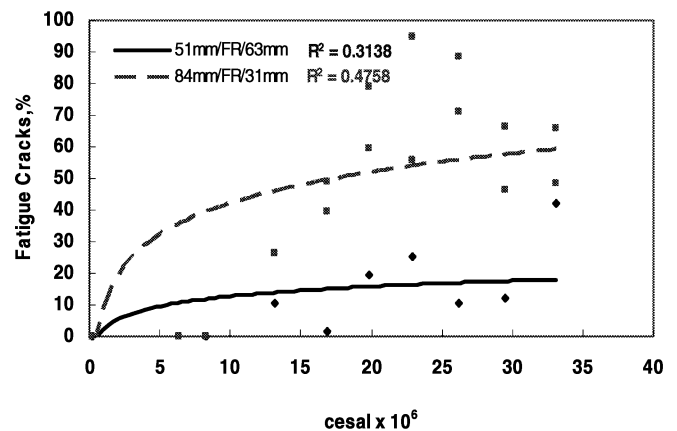
Fig. 4. Fatigue Cracks for LTPP-California Sections with Different Overlay Scenarios.

As part of the SPS-6 experiment, the order of overlay lifts was investigated. Two sections were built following Caltrans normal practice (from bottom to top) using about 30.0mm leveling course followed by a fabric reinforcement (FR) layer and a top layer of asphalt approximately 76.0mm thick. In another section, the bottom overlay lift was built with approximately 63.0mm thick, and this layer was followed by the FR layer and a top layer of approximately 51.0mm thick. The effect of the order in which overlay lifts were constructed on fatigue cracks is presented in Fig. 4. It can be seen in that sections with thick leveling course (63mm) exhibited lower percentages of fatigue cracks at the same cumulative traffic level, as compared with sections that followed Caltrans-normal-practice with a leveling course of 30.0mm thickness. With only a few sections analyzed, more sections and further analyses will be needed to draw more solid conclusions with regard to this issue

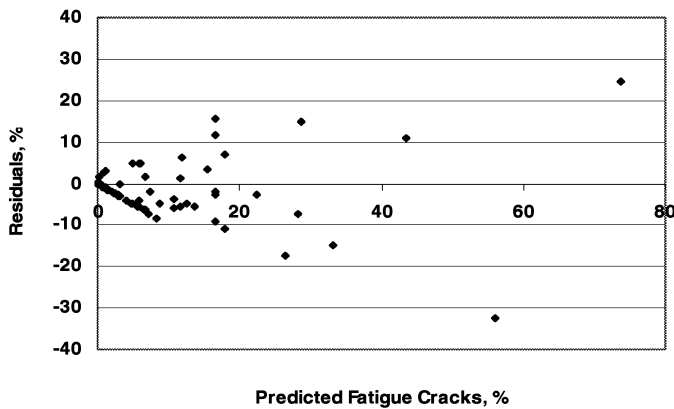
Fig. 5. Residuals vs. Predicted Fatigue Cracks for the WF Region Model.

In order to check the robustness of the models, residuals are plotted against the percentages of predicted fatigue cracks in Figs. 5, 6, and 7 for the WF, WNF, and LTPP-California models, respectively. These plots help to detect multicollinearity among explanatory variables after the models are being developed [11]. No specific pattern is observed for the three models, ruling out multicollinearity among explanatory variables and ensuring well-specified models. The predicted fatigue crack percentages are

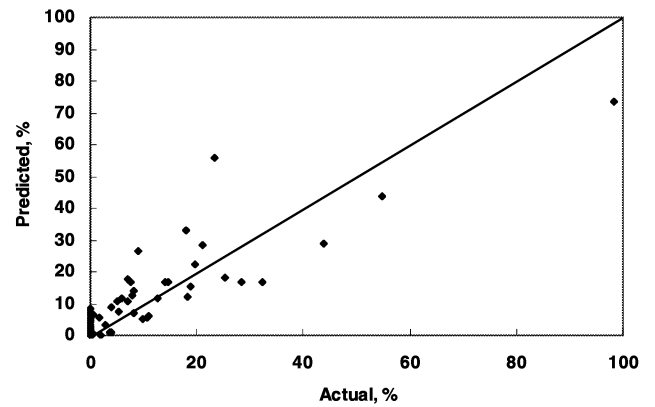
Fig. 8. Actual vs. Predicted Fatigue Cracks Percentage for the WF Region Model.

plotted against the actual percentages with points clustering along the line of equality suggesting good predictability as shown in Figs. 8, 9, and 10 for the WF, WNF, and LTPP-California models, respectively.

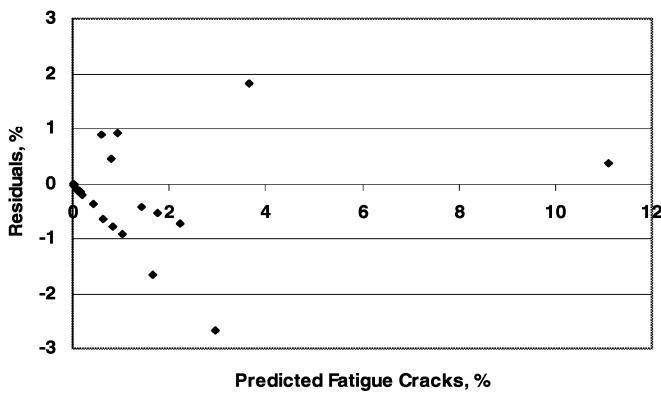
Fig. 6. Residuals vs. Predicted Fatigue Cracks for the WNF Region Model.

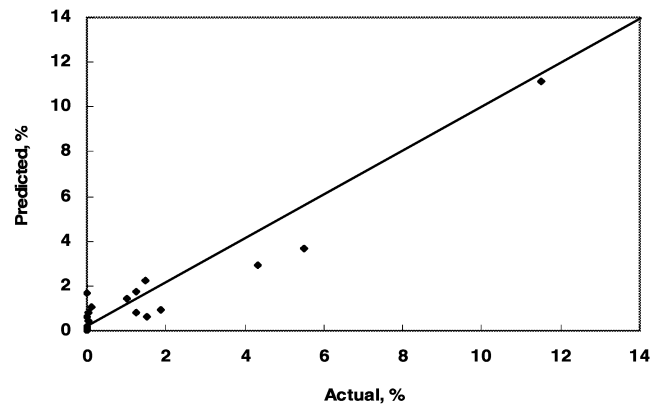
Fig. 9. Actual vs. Predicted Fatigue Cracks Percentage for the WNF Region Model.

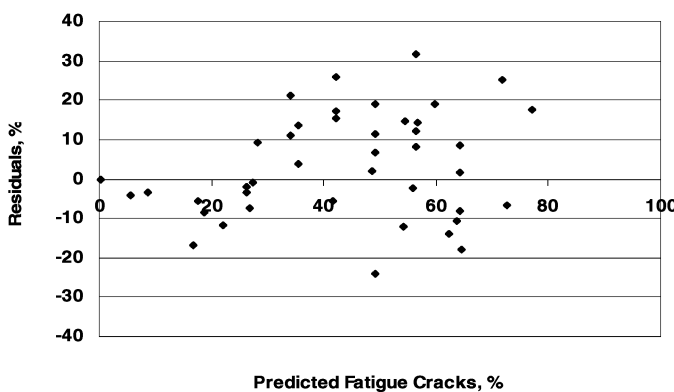
Fig. 7. Residuals vs. Predicted Fatigue Cracks for the LTPP-California Sections Model.

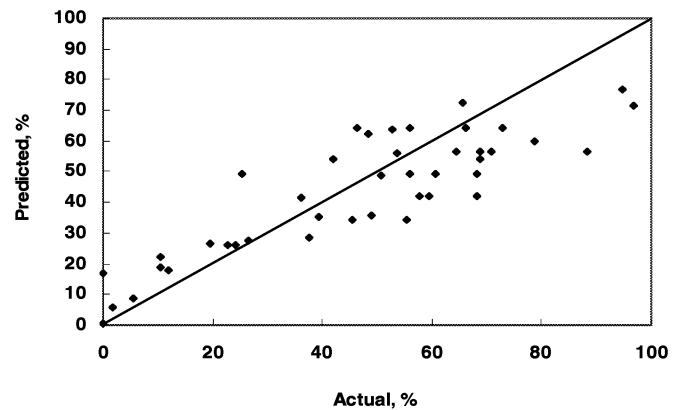
Fig. 10. Actual vs. Predicted Fatigue Cracks Percentage for LTPP-California Sections Model.

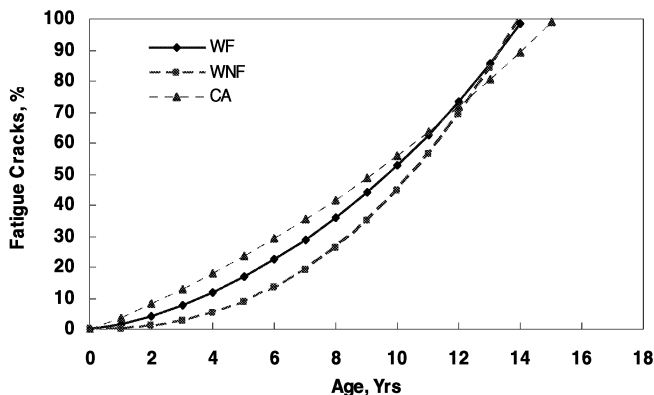
Fig. 11. Variation of Fatigue Cracks with Age.

Presented in Fig. 11 is the variation of alligator cracks with age for sections in the WF region, the WNF region, and in California. As shown, sections in the WNF region are expected to outperform their counterparts in the WF region and in California up to an age of approximately 12 years. It is noted that all sections are expected to experience approximately 100 percent fatigue (alligator) cracks after about 14 years of service. The California sections are expected to

exhibit approximately 56 percent alligator cracks after 10 years of service.
